CONDITION AND VALUATION SURVEY REPORT

# "SAMPLE MOTOR YACHT"

This Condition and Valuation Survey Report has been prepared following the inspection, both ashore and afloat, of the 2018 (built 2017) model 14.92 m Jeanneau Prestige 500 vessel named SAMPLE MOTOR YACHT, carried out at the request of Buyer (name withheld) on September 2026.

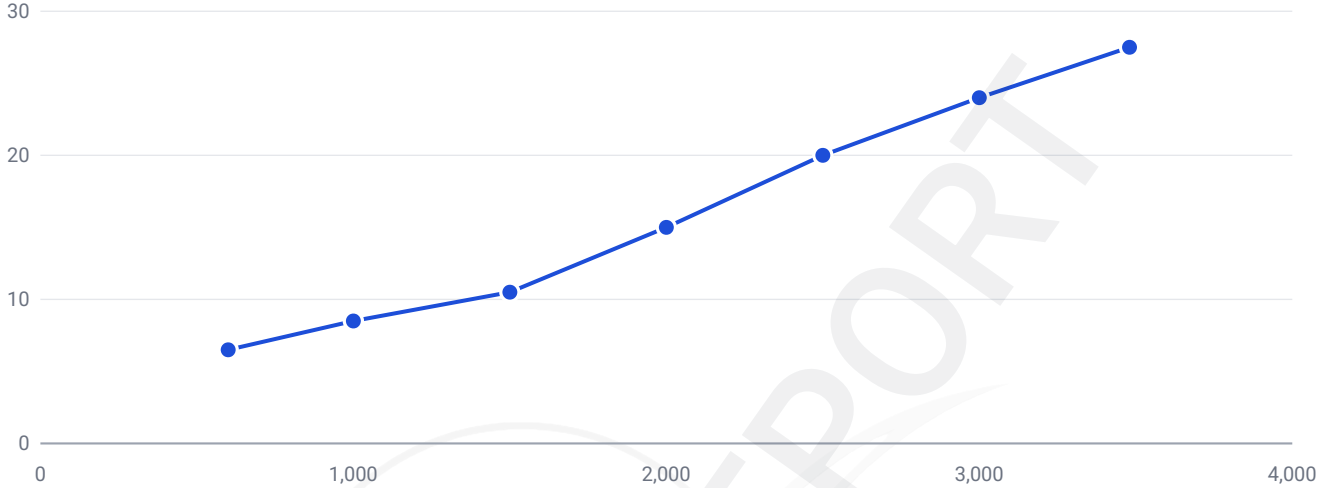
#### Speed vs RPM kn · rpm

The rated speed of the engine is 3,500 rpm. The highest speed reached during the sea trial was 3,480 rpm, which corresponds to 99.4% of the rated speed.

The 3,480 RPM reached at full throttle is 99.4% of the rated full throttle RPM stated on the engine data plate (3,500 RPM); there is no loss of RPM, and this indicates that the propeller pitch is suited to the engines. The difference in RPM between the two engines is within measurement tolerance. Coolant temperature and oil pressure remained within normal limits at all stages; no temperature rise or drop in oil pressure was observed at full throttle. This data set shows that the engines deliver the expected performance under load.

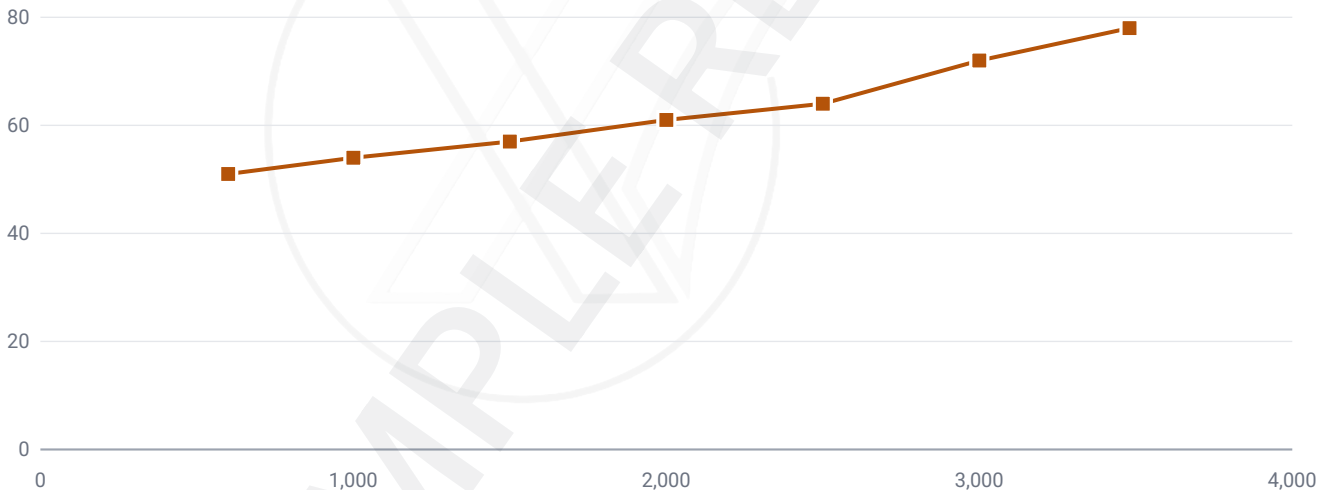
#### Sound level vs RPM · Enclosed wheelhouse dBA · rpm

The sound level was measured using a digital sound level meter at two separate operating stages in the enclosed wheelhouse.

It was found to be 78 dBA at full throttle and 64 dBA at cruising speed. In the surveyor's opinion, these values are within the normal range for this class of motor yacht; the measurement was taken with doors and windows closed and the air conditioning off.

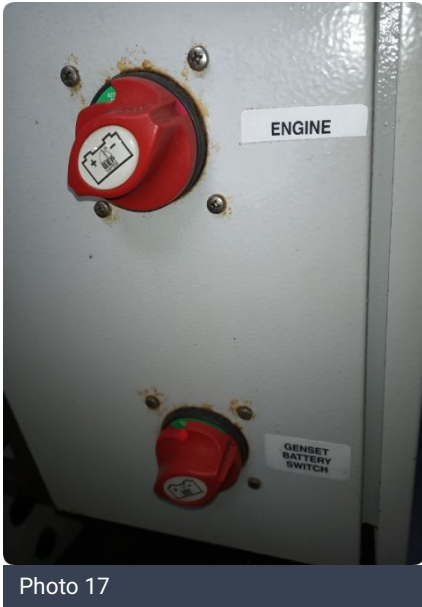
Photo 17

The main engine and generator battery isolator switches (Blue Sea Systems) are located in the engine room, labelled.

The switches were operated individually; it was verified on the indicator that the circuit was broken and made in the off and on positions. It was observed that the labelling clearly indicates which bank each switch belongs to, allowing the correct switch to be located quickly in an emergency.

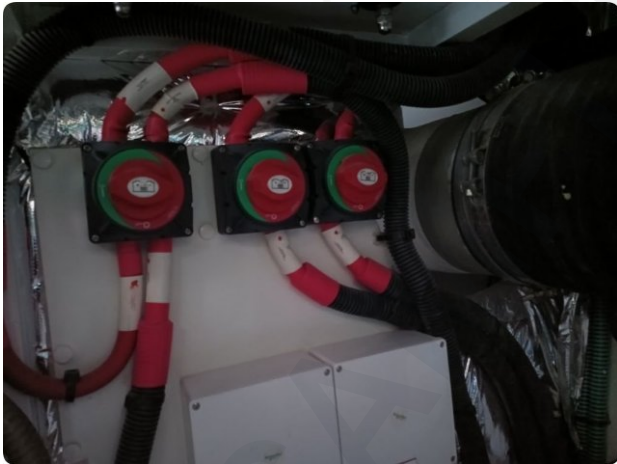
Photo 18

The main DC breakers are located on the distribution panel in the engine room; they were operated and observed to break the circuit.

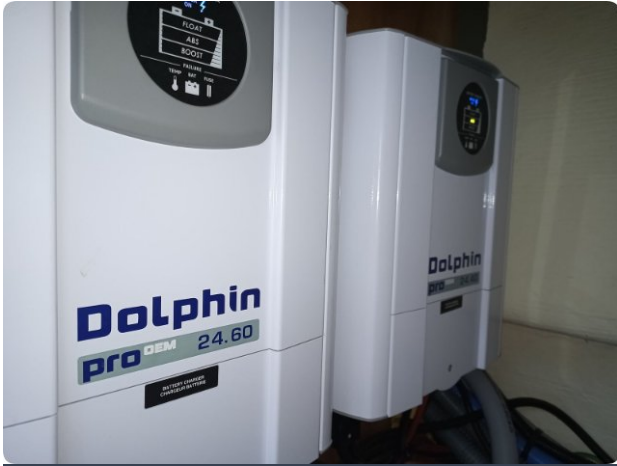
Photo 19

There are 2 chargers of the Dolphin Pro Dem 24.60 and 24.40 models; they were found to be SERVICEABLE.

The units were OPERATED with shore power connected, and were observed to switch to the charging stage via the indicator lamps. The mounting position, ventilation and cable connections were also checked, and no adverse condition was found.

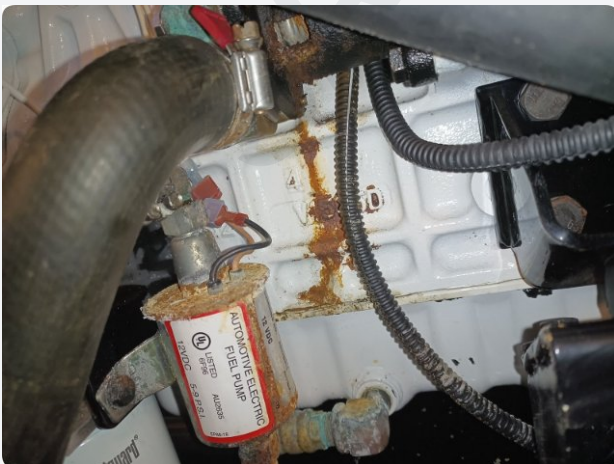
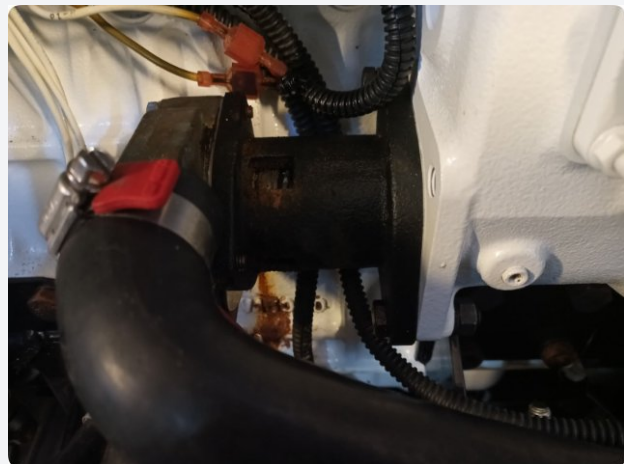
**Finding B-3**

It is recommended that this be repaired.

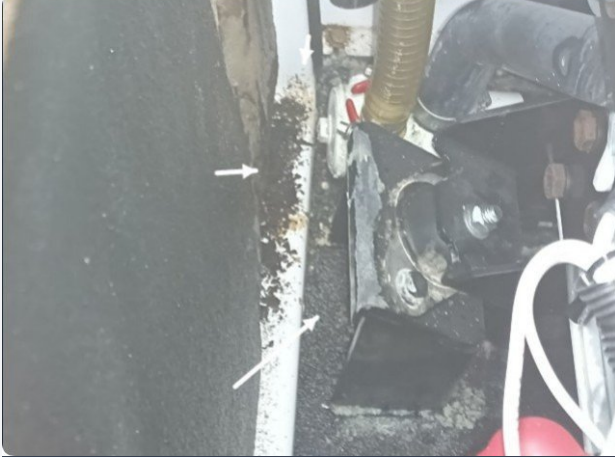
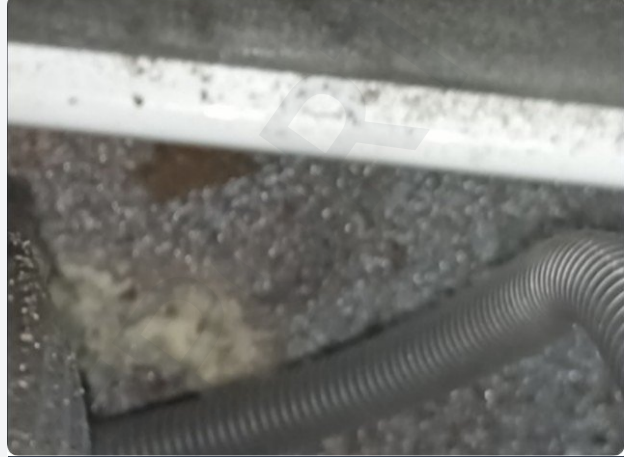
**Finding B-4**

It is recommended that it be repaired and serviced again.

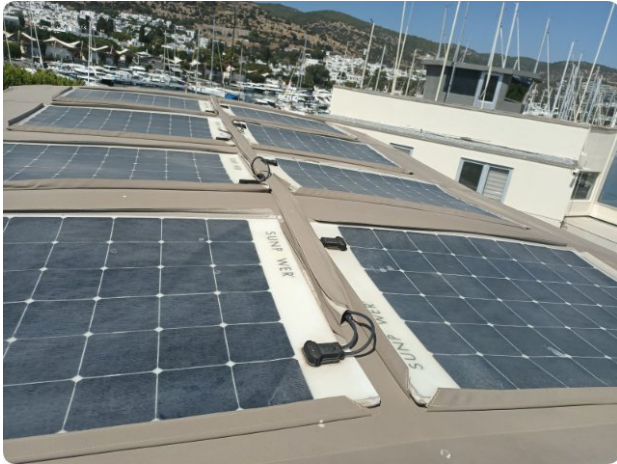
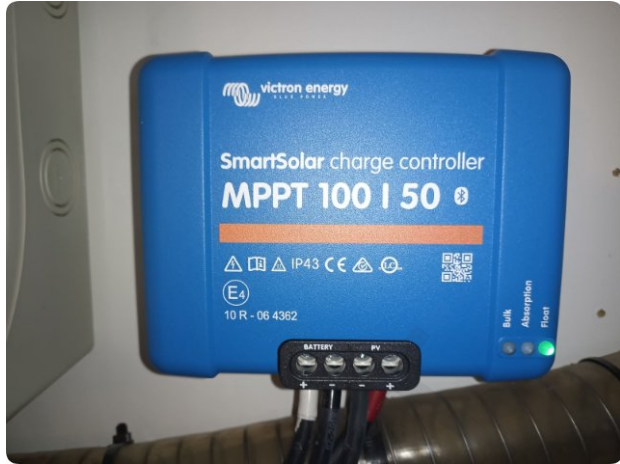
Solar panels, fitted subsequently on the flybridge, supply the battery bank via a Victron charge regulator. The regulator display showed that the panels were supplying current.

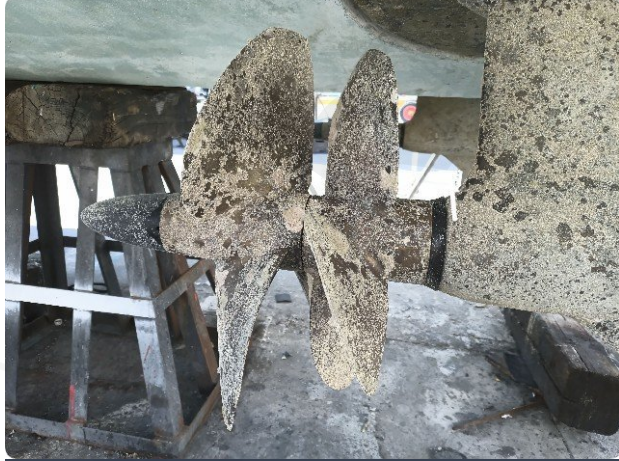
The propellers were examined while the vessel was ashore; no bending, cracking or cavitation erosion was found on the blades.

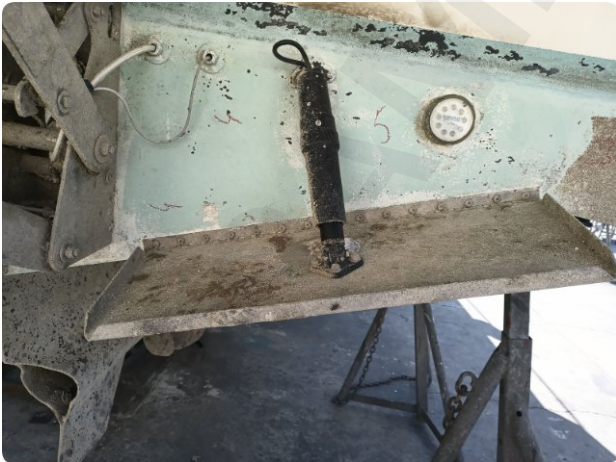
Photo 40

The trim tabs were operated, and both tabs are performing their function.

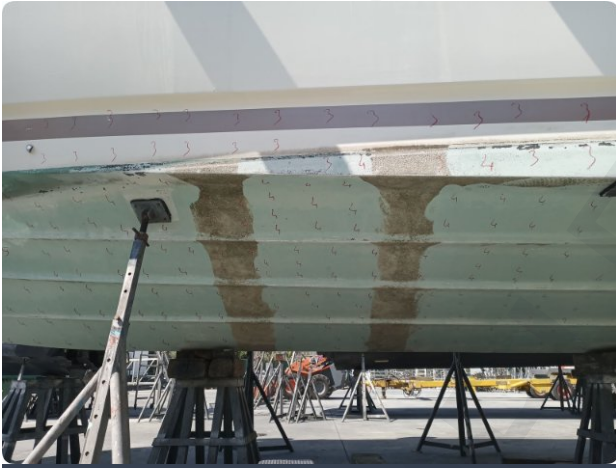
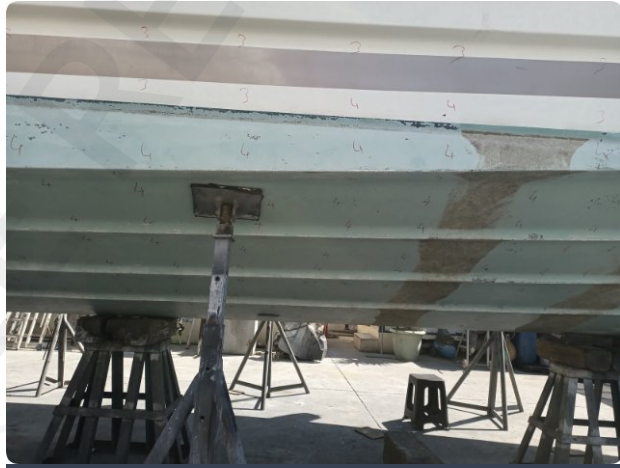
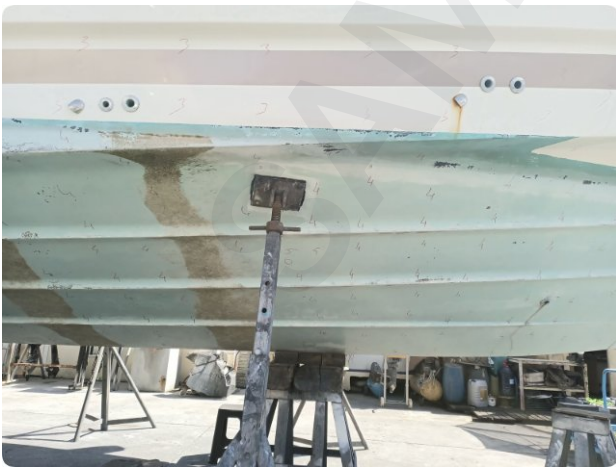
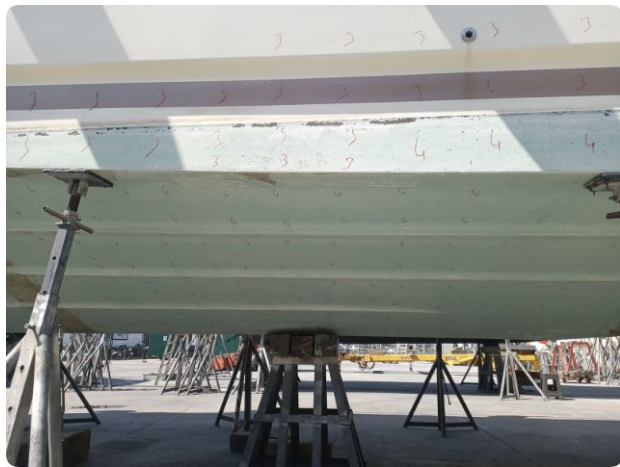
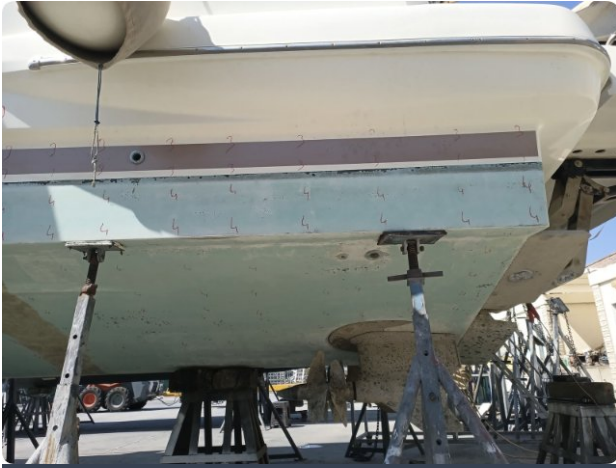
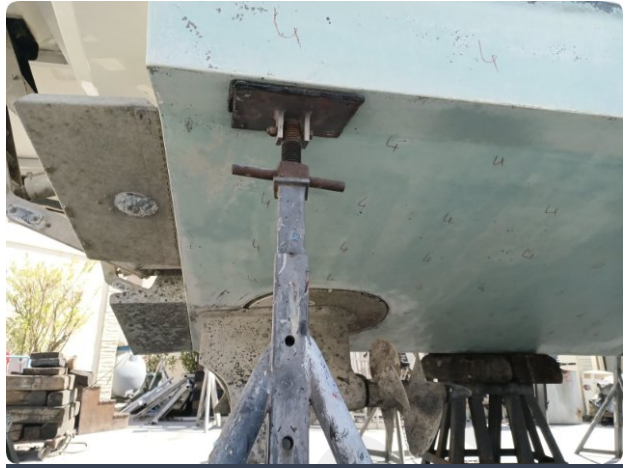
No visible osmotic blistering (moisture-induced blistering beneath the gelcoat) was found on the underwater hull. The entire hull was checked with a Tramex Skipper 5 moisture meter, phenolic hammer and thermal camera, and no adverse condition was found.
