YACHT OUT-OF-WATER HULL SURVEY REPORT

# "SAMPLE MOTOR YACHT"

FILE NO.  
ORNEK-03-EN

SURVEY DATE  
September 2026

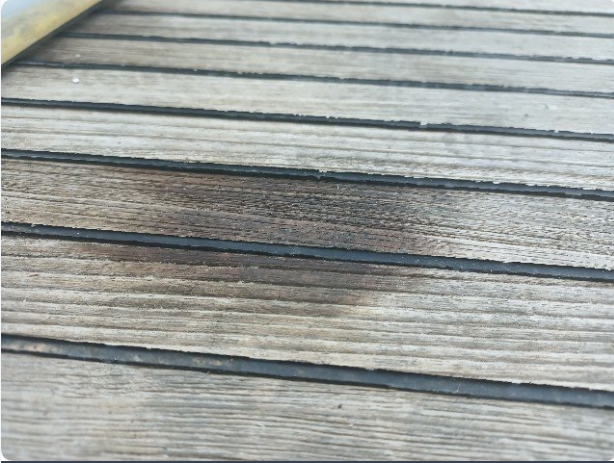
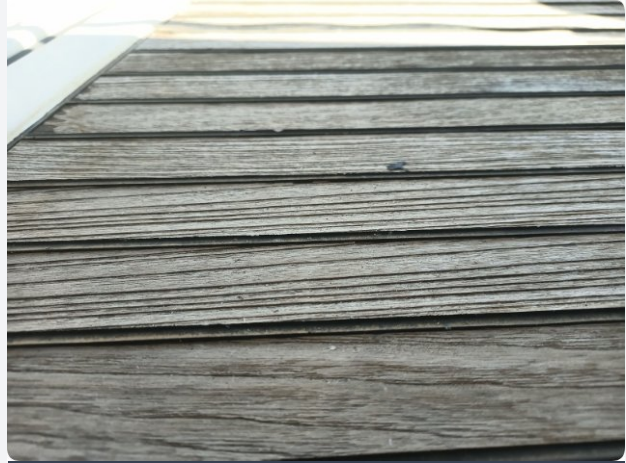
Surface wear and discolouration consistent with use were observed on the teak decking of the aft platform. No lifting of the decking planks or separation at the caulking seams was found.

It is recommended that the teak surface be maintained with a suitable cleaner, and that the caulking seams be inspected at the start of each season.

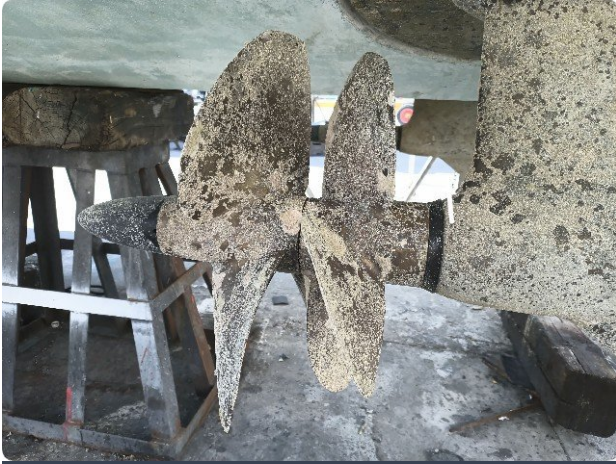
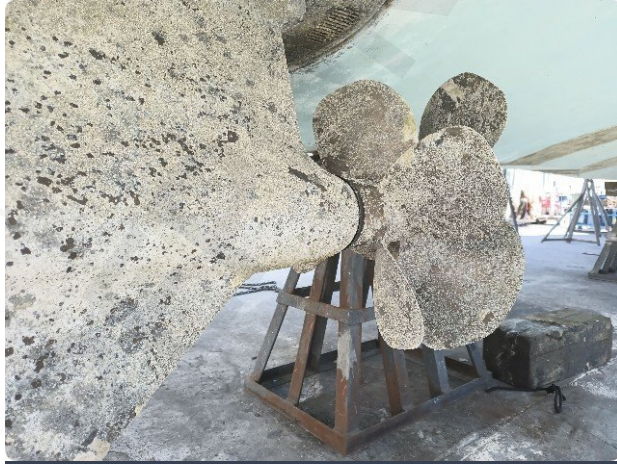
No bending, cracks, nicks or cavitation erosion were found on the blades; the blade edges are uniform and symmetrical. The relative position of the forward and aft propellers and the blade pitch angles were visually compared, and no difference was observed.

The propellers were turned by hand; no play, binding or unusual noise was found in the shaft bearings. Detailed surface inspection was limited due to marine growth on the blade surfaces (see Findings).

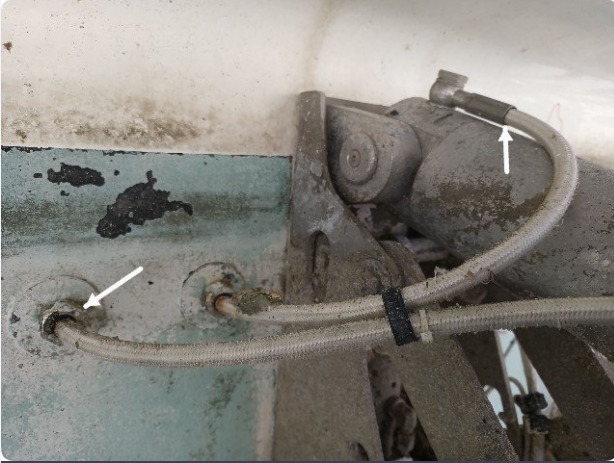
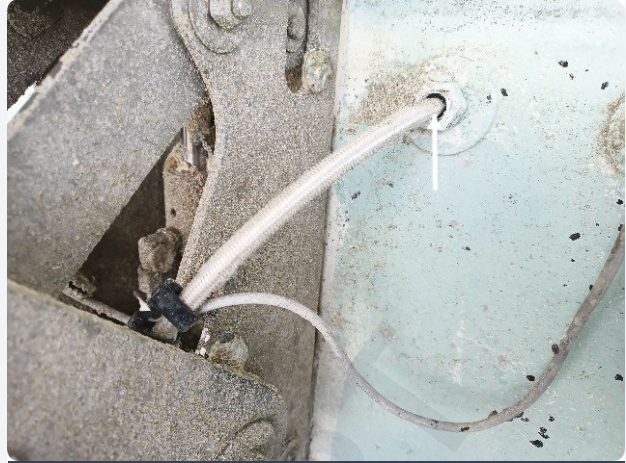
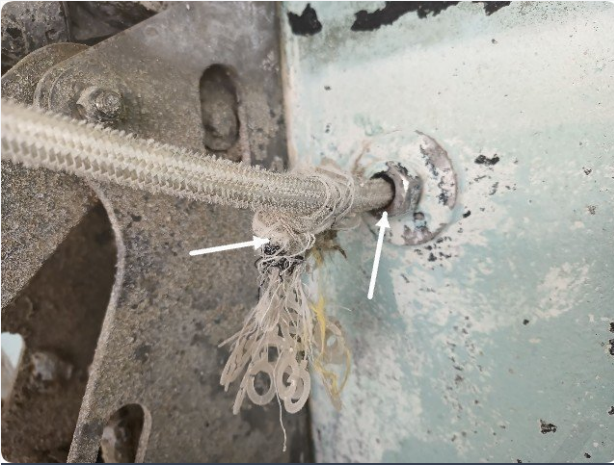
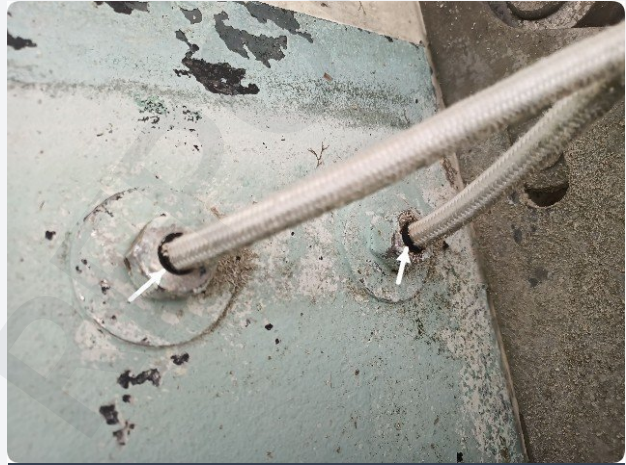
The outer sheathing protecting the bathing platform's hydraulic hoses from seawater was found to be deformed. No leakage, cracking or swelling was observed in the hoses themselves.

It is recommended that the protective sheathing be renewed and that the hoses be reviewed at the next service.

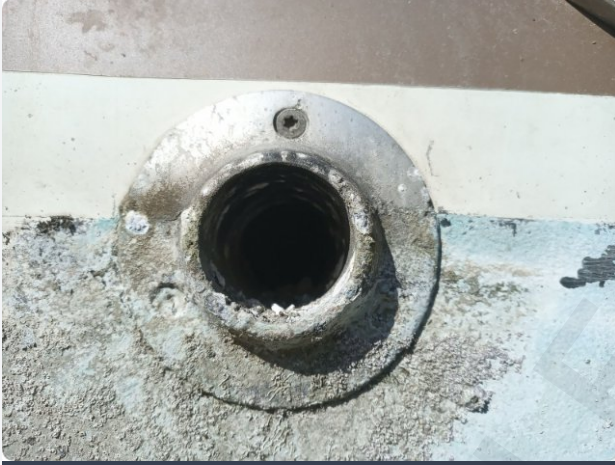
Photo 11

Surface corrosion was found at the deck drain outlet on the port topsides. The drain was open and functional; no sign of leakage was observed at the hull penetration.

It is recommended that the corrosion be cleaned off and the surface protected, and that the drain outlet be renewed should the corrosion progress.

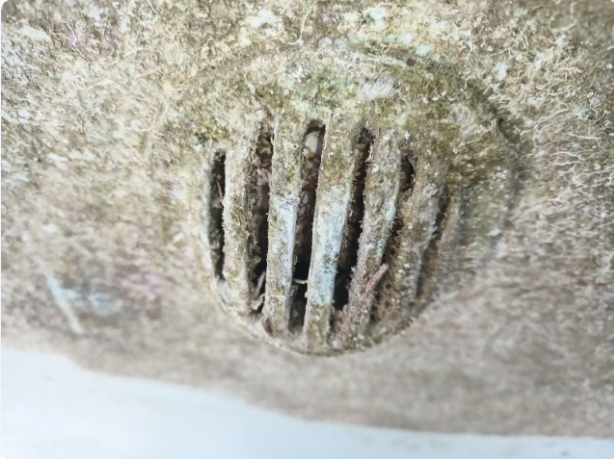
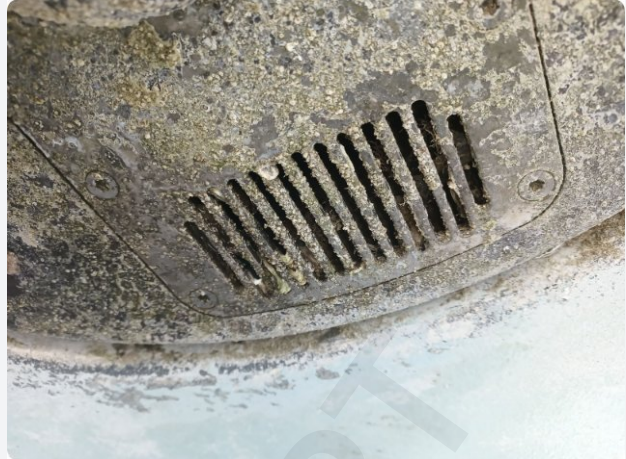
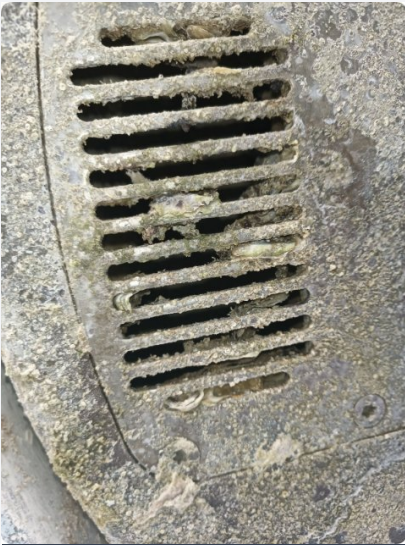
The seacock inlets, skin fittings and hull earth plate below the waterline were found to be covered with marine growth and a layer of weed. No other adverse condition was found in the seacock bodies or penetrations.

It is recommended that the seacock inlets, skin fittings and earth plate be cleaned of marine growth before the vessel is relaunched, and that the seacocks be checked by operating them open and closed after cleaning.

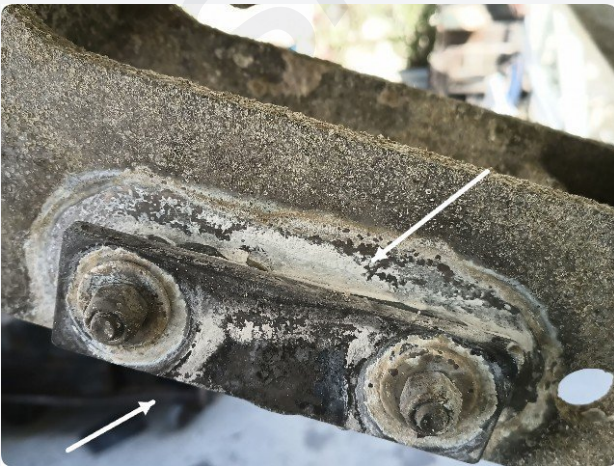
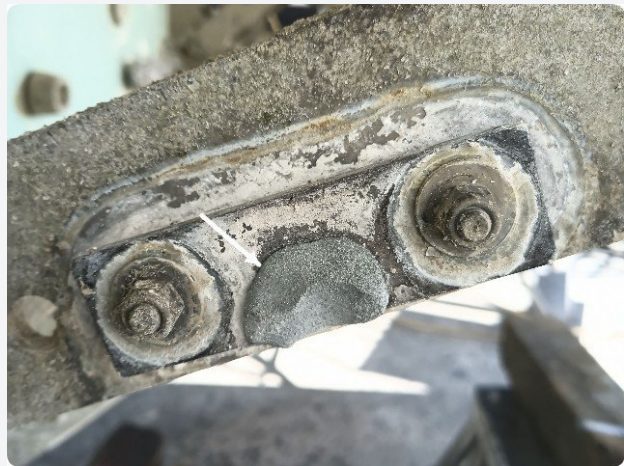
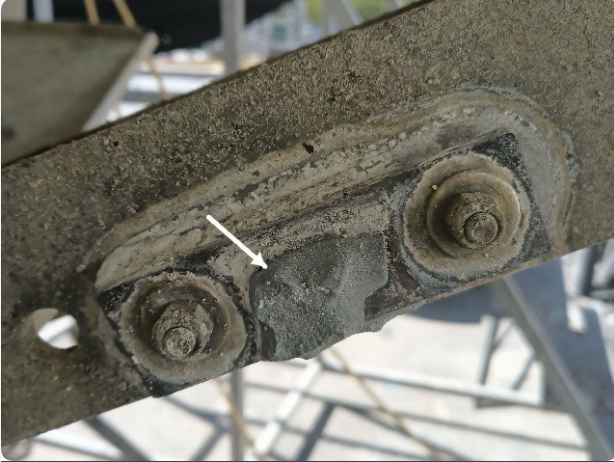
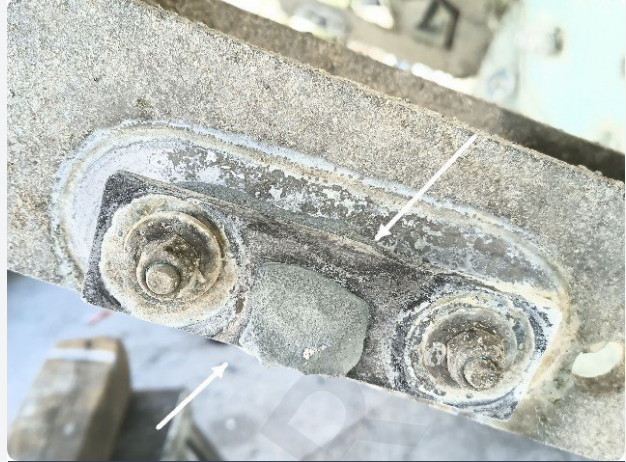
Wastage of the sacrificial anodes overall was found to be approximately 80%; the generally accepted 50% depletion threshold in the industry has been exceeded. Wastage is similar and even across all anodes and does not indicate accelerated consumption caused by stray current.

It is recommended that the sacrificial anodes be renewed before the vessel is relaunched, and that the new anodes be fitted only after the mounting surfaces have been cleaned back to bright metal.

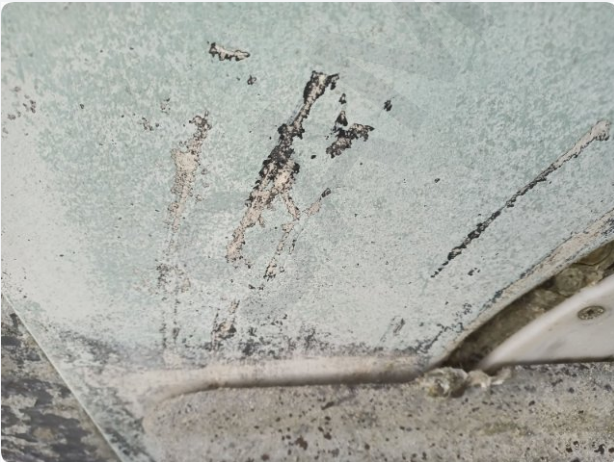
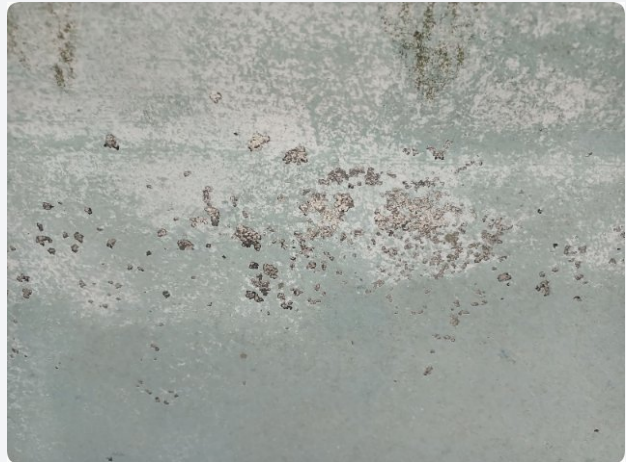
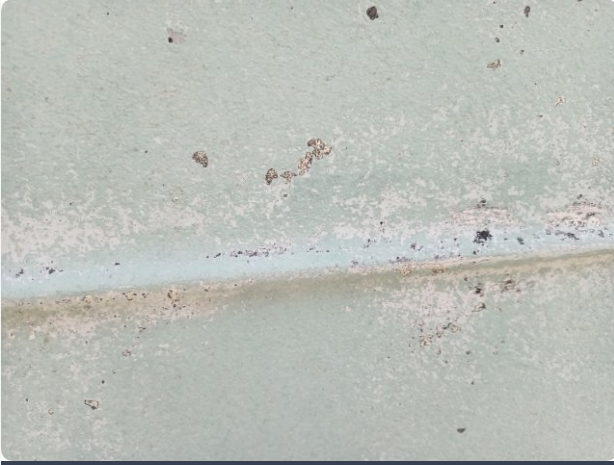
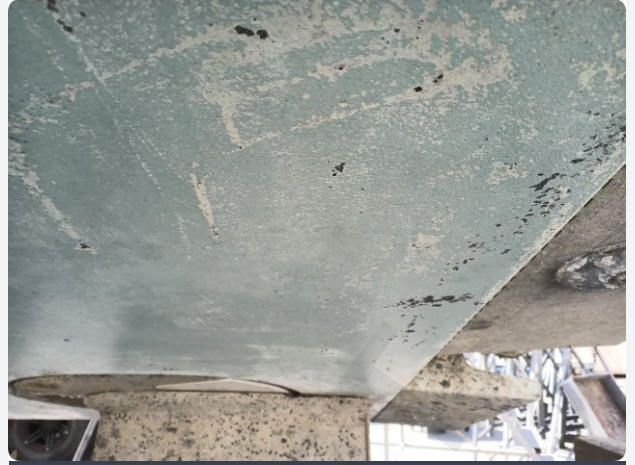
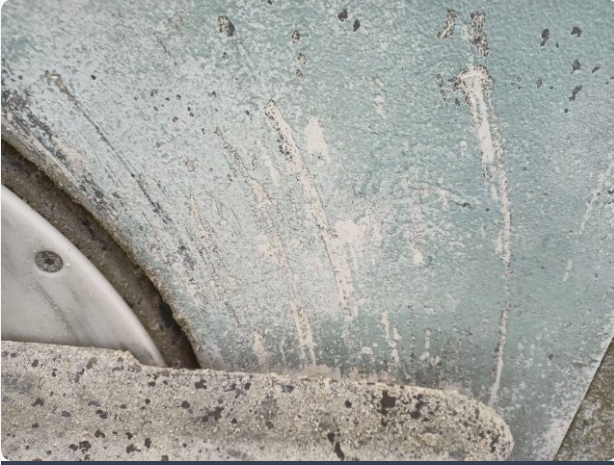
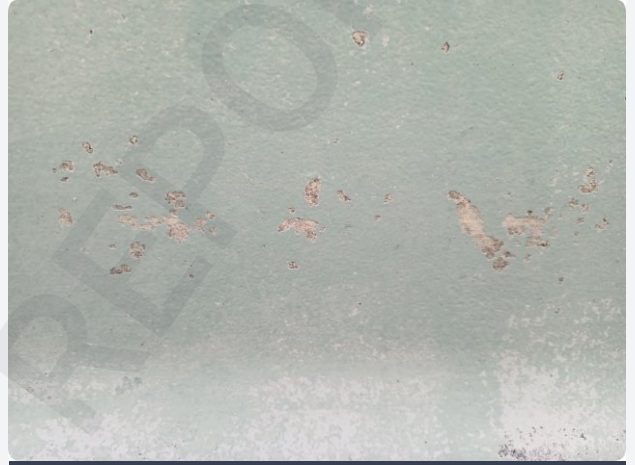
The antifouling paint has reached the end of its service life. In some areas the paint layer has worn through to the gelcoat, while in other areas thickened old layers are flaking off.

It is recommended that the flaking layers be removed by sanding, that the exposed areas be primed with a suitable barrier primer, and that new antifouling be applied over the entire underwater hull. This work must be completed with the vessel ashore.
