MARINE SURVEY REPORT

# "SAMPLE MOTOR YACHT"

FILE NO.  
ORNEK-01-EN

Pre-Purchase Condition Survey

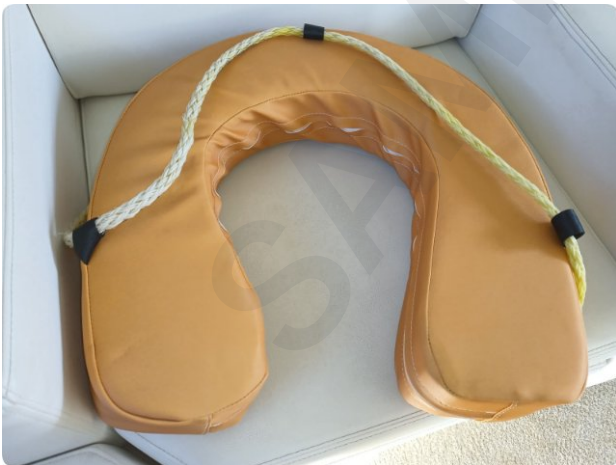
Photo 2

1 yellow horseshoe-shaped lifebuoy was found.

The body, straps and attached line of the lifebuoy were inspected; it was observed that the vessel's name was not marked on it and that it was not fitted with a light/strobe to provide night-time visibility.

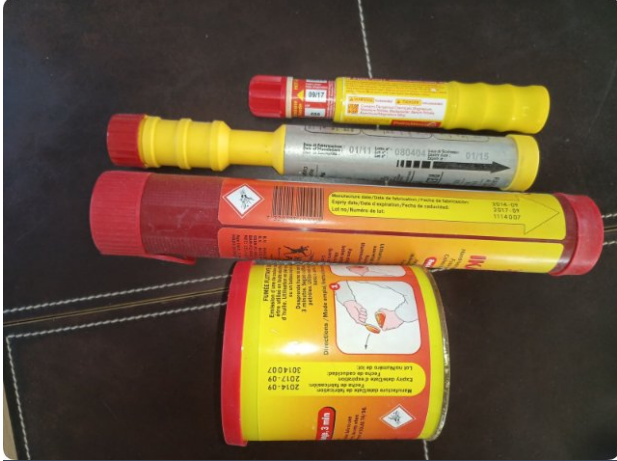
Photo 6

The expiry date on each was checked, and all were found to be out of date. Pyrotechnic distress signals should be stored in a waterproof container in an easily accessible location, and expired ones should be disposed of properly.

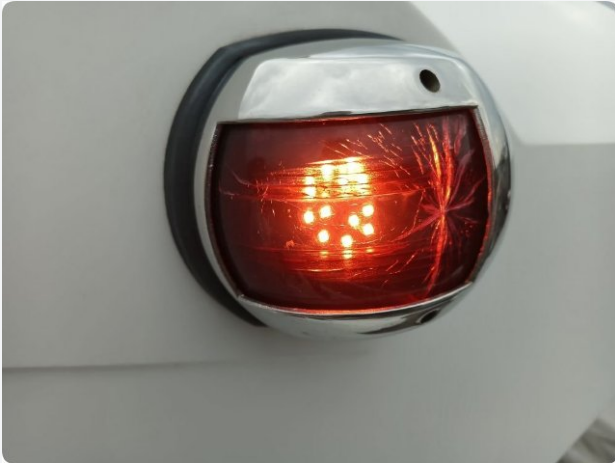
Photo 7

the dimly burning light be checked. Navigation lights directly affect the visibility of the vessel during night navigation.

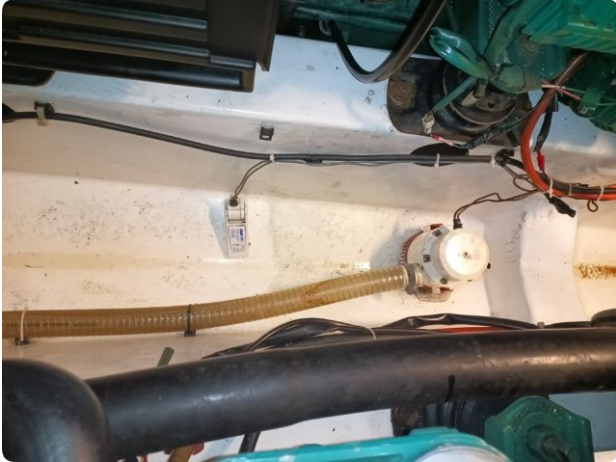
Photo 17

The high bilge water alarm is integrated with the automatic discharge pumps; when the pumps activated, an audible and visual warning was observed in the wheelhouse. OPERATED.

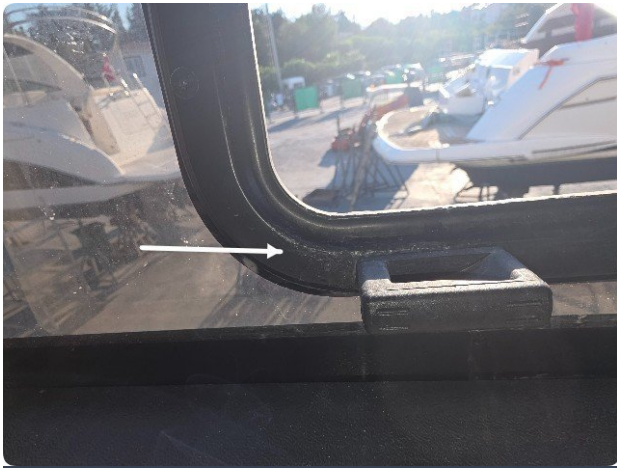
Photo 43

Blistering is present on the starboard portlight; the remaining portlights were found to be in good condition, with locks holding securely and seals retaining their flexibility. The portlight surrounds were also checked with a moisture meter, and no elevated readings relative to the surrounding area were obtained.

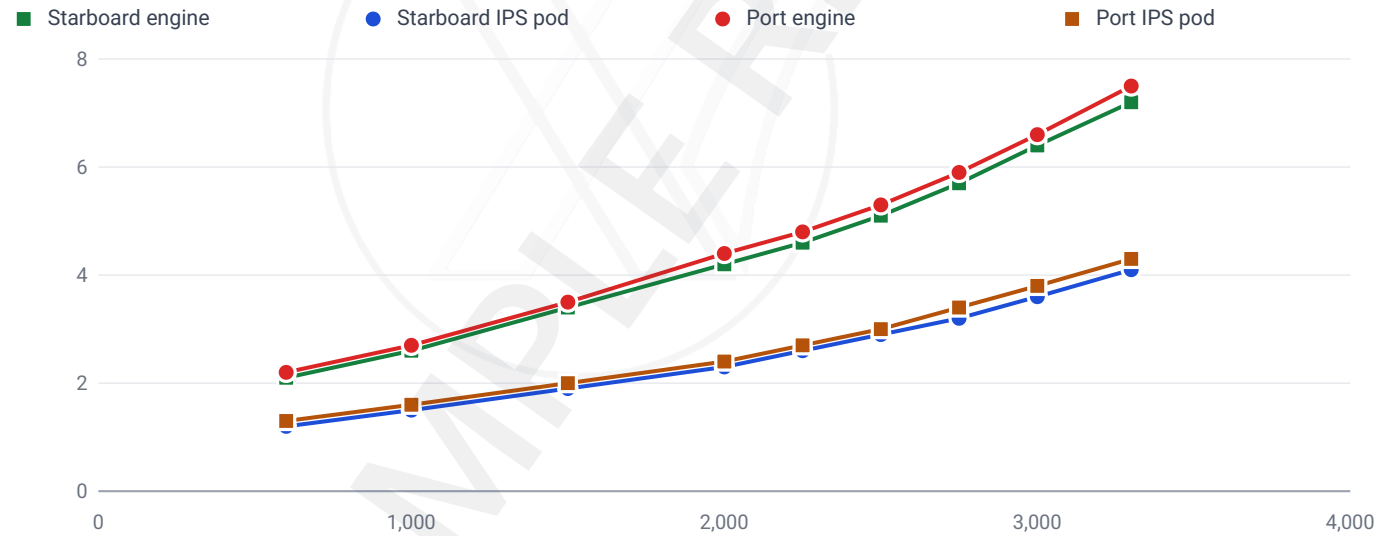
**Vibration vs RPM · Measurement run 1 mm/s · rpm**

Vibration measured on the engine casings increased steadily with RPM, recorded at full throttle as 7.2 mm/s on the starboard engine and 7.5 mm/s on the port engine; the difference between the two engines is small. Values at the IPS units remained at approximately half the level of the engine casing, with port and starboard close to each other. No sudden increase at a specific RPM was observed at any measurement point. Vibration remained low at the accommodation and deck points, with the highest value of 2.8 mm/s measured at the aft deck at full throttle.

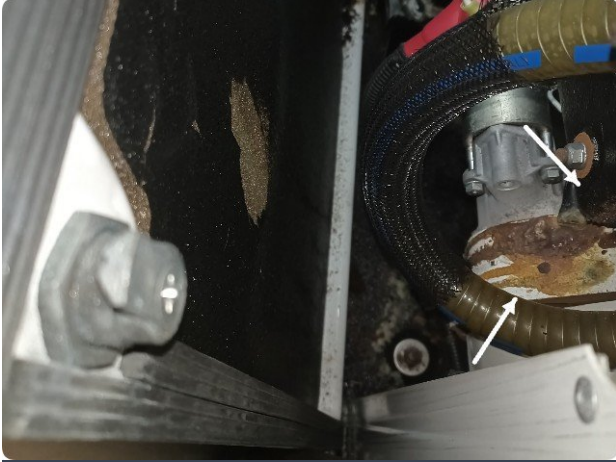
Photo 141

Diesel leakage from the fuel line connections, deterioration of the sound and heat insulation, and the spread of particles shed from this insulation over the unit were found around the unit.

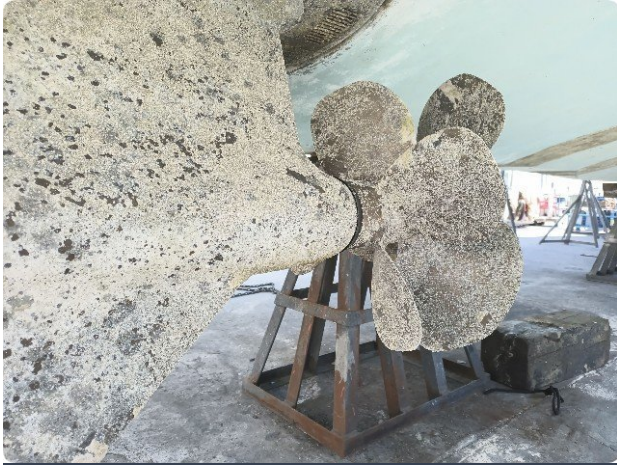
Photo 167

The specialist paint applied to the blades was observed to have flaked off in some areas. Detailed surface examination was partially limited due to marine growth on the blade surfaces.
