CONDITION AND VALUATION SURVEY REPORT

# "SAMPLE MOTOR YACHT"

This Condition and Valuation Survey Report has been prepared following the inspection, both ashore and afloat, of the 2018 (built 2017) model 14.92 m Jeanneau Prestige 500 vessel named SAMPLE MOTOR YACHT, carried out at the request of Buyer (name withheld) on September 2026.

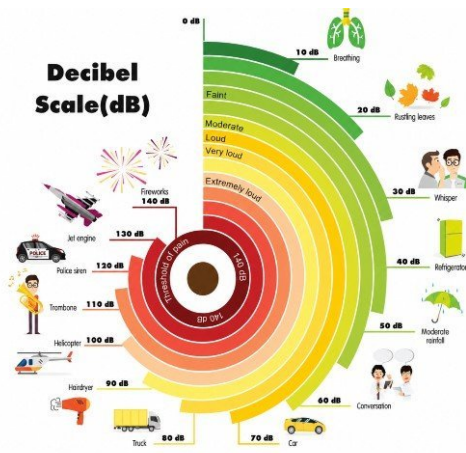
Photo 9

The sound level was measured using a digital sound level meter at two separate operating stages in the enclosed wheelhouse.

It was found to be 78 dBA at full throttle and 64 dBA at cruising speed. In the surveyor's opinion, these values are within the normal range for this class of motor yacht; the measurement was taken with doors and windows closed and the air conditioning off.

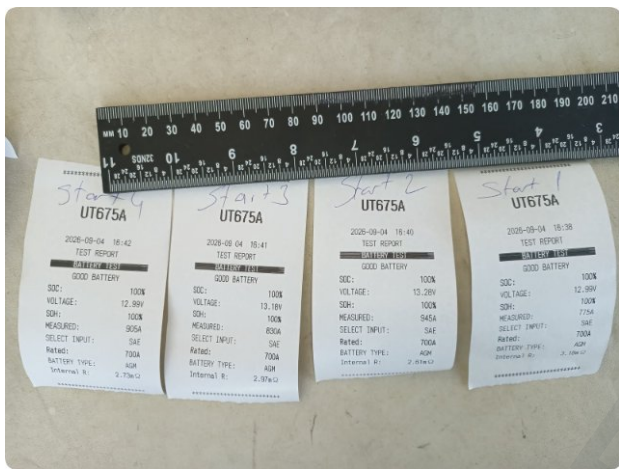
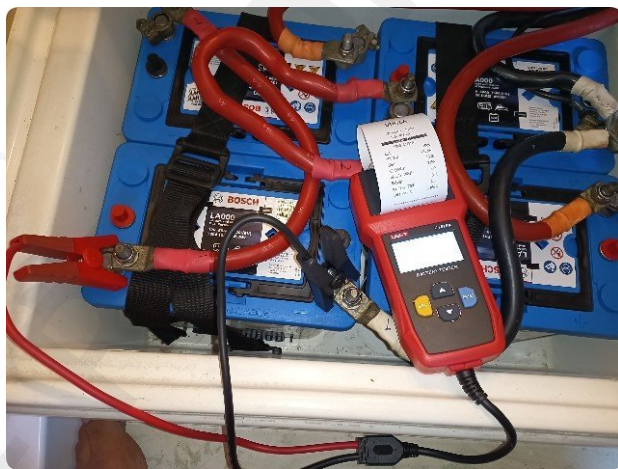
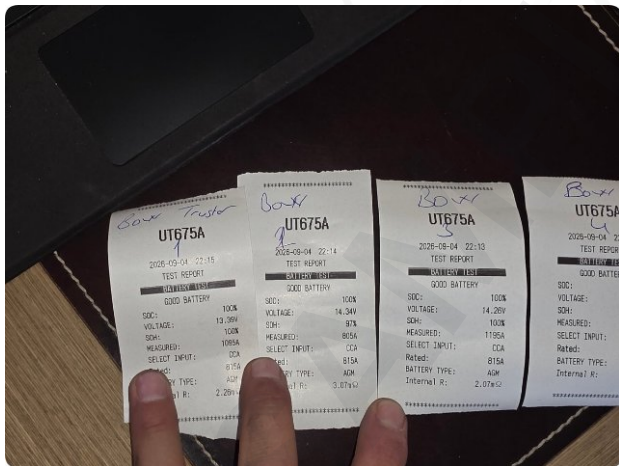
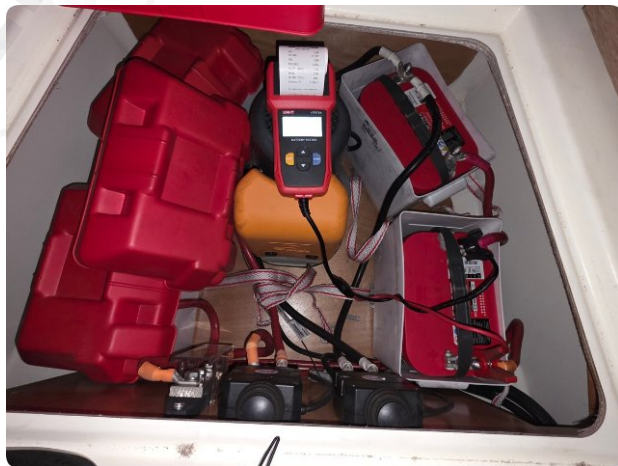
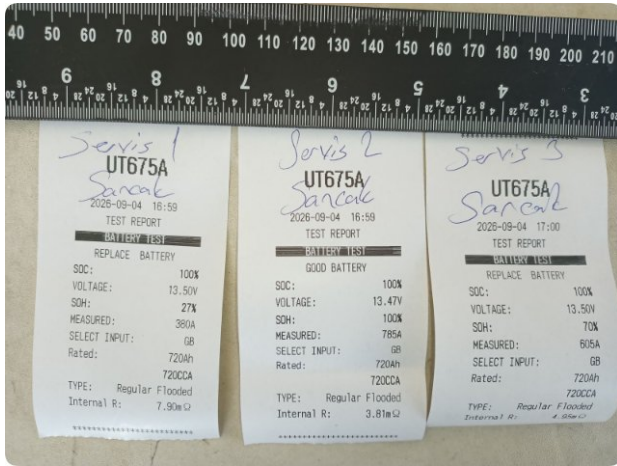
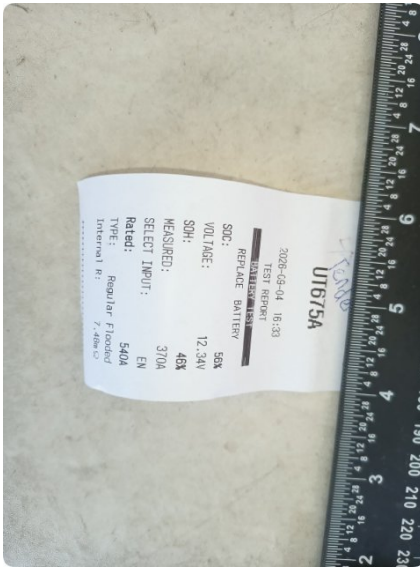
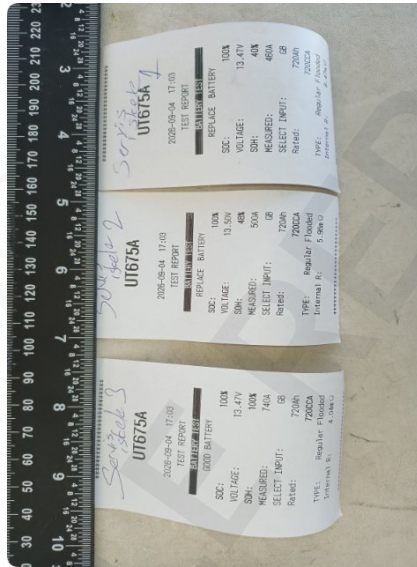
Tender 46% · Generator 100% · Start batteries (4 units) 100% · Port service 40, 48, 100% · Starboard service 27, 100, 70% · Bow thruster 100, 100, 100, 97%.

The batteries were also visually inspected; the terminals were checked for oxidation and the casings for swelling or electrolyte leakage. Batteries found to have a low state of health are addressed separately in the Findings section.

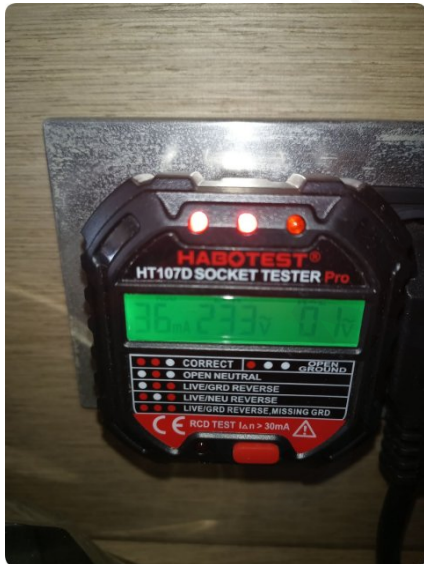
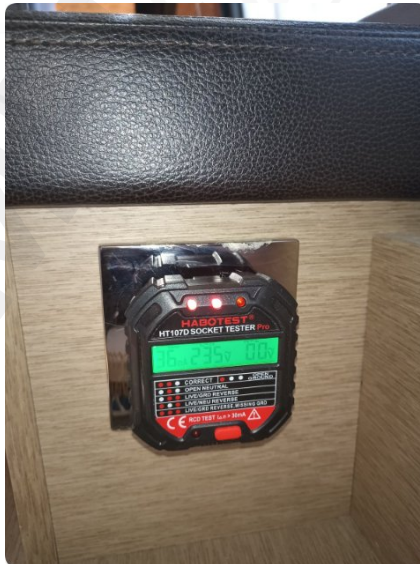
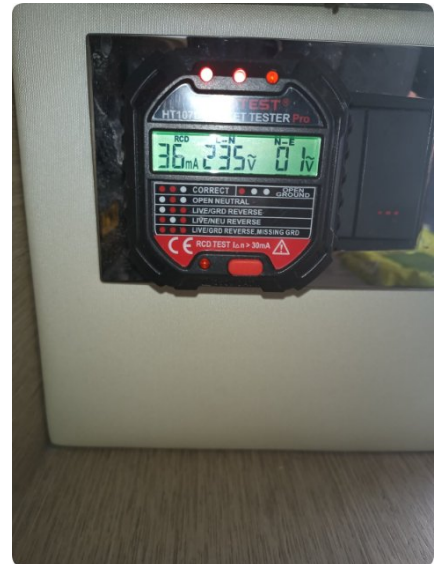
The AC sockets on board are of the earthed (Schuko) type, distributed in the saloon, cabins and cockpit.

The sockets were POWERED UP; polarity and earth checks were carried out at all sockets sighted using a socket tester, and the connections were found to be correct. No cracking or oxidation was found on the covers and frames, and they were found to be SERVICEABLE.

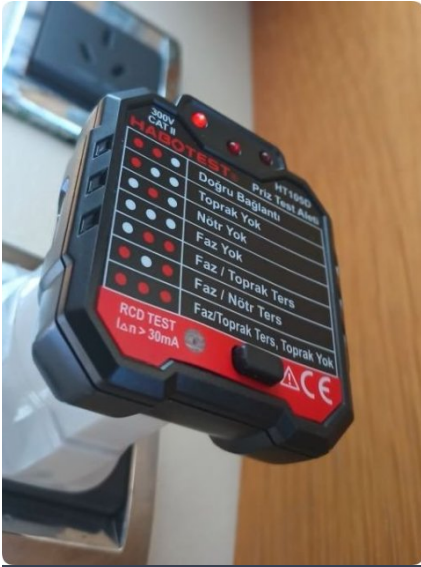
Photo 24

Polarity and earth checks were carried out at all AC sockets sighted using a socket tester.

The test was repeated separately with both the shore power supply and the generator supply energised; no reversal of phase and neutral, earth discontinuity or mixing of earth and neutral was found. The connections were found to be correct.

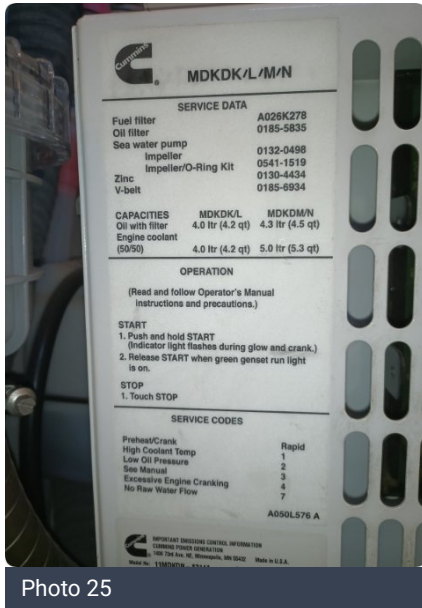
Photo 25

The manufacturer's nameplate and warning plates on the generator are in place and legible.

The power, voltage, frequency and serial number details on the nameplate were read and compared with the particulars given in the report, and were found to be consistent.

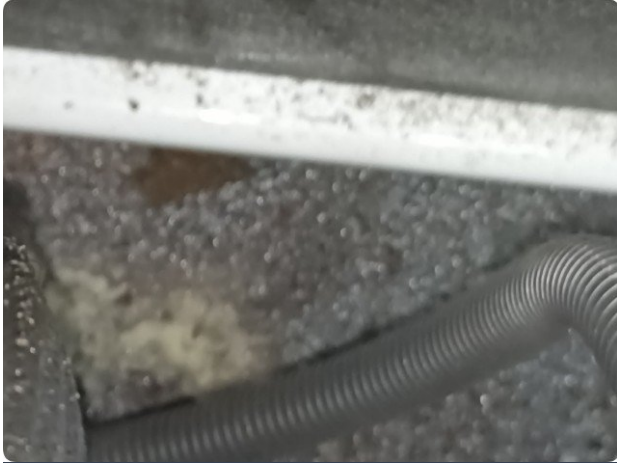
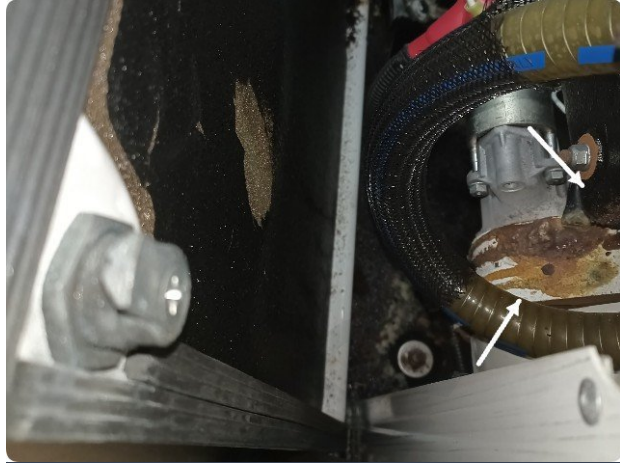
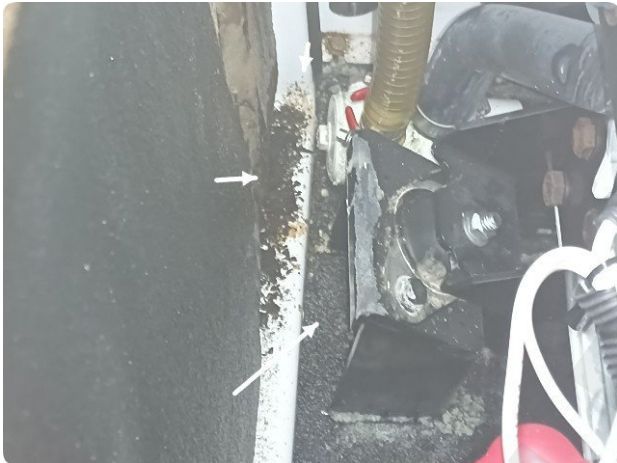
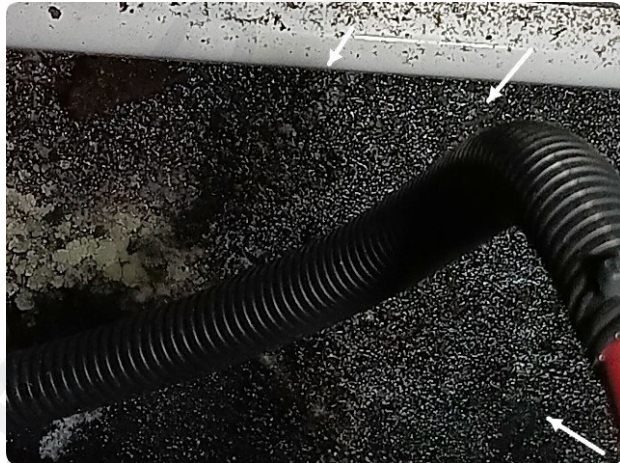
The generator was started with shore power disconnected and was OPERATED under load throughout the survey. No excessive cranking or excessive smoke was observed at start-up; the RPM was found to settle quickly, and the

running noise was found to be smooth. During operation, the instrument panel, the cooling water flow at the exhaust outlet and the area around the unit were monitored. The matters found during the observation are described in the Findings section.

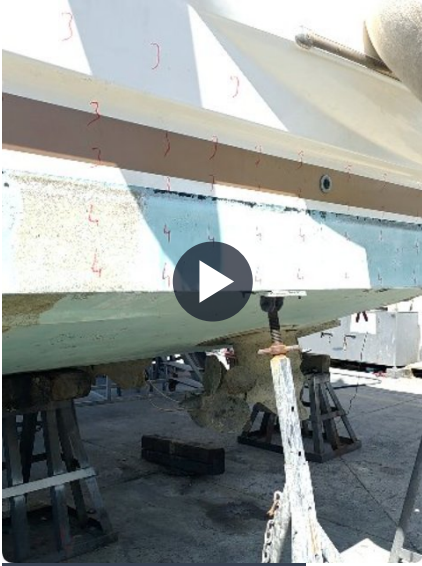
Video 1 · 0:20

The area where the slings were positioned, together with the IPS legs, propellers and pod housings, was found not to have been sufficiently cleaned; outside of these areas, the entire underwater hull surface could be examined.

The osmosis and moisture meter readings taken were clean; no finding indicative of delamination, concealed repair or water-saturated areas was found. No adverse condition was found.
