YACHT OUT-OF-WATER HULL SURVEY REPORT

# "SAMPLE MOTOR YACHT"

FILE NO.  
ORNEK-03-EN

SURVEY DATE  
September 2026

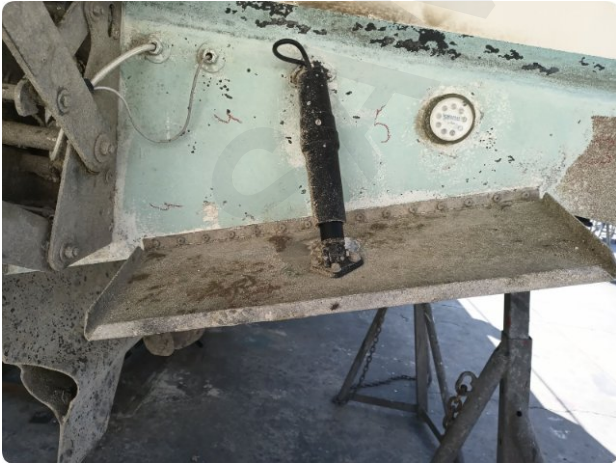
Photo 10

The trim tabs were OPERATED, and both tabs were found to be functioning correctly.

The trim tabs were moved to the fully down and fully up positions; the movement was observed to occur at equal speed on both sides and without binding. The hinge lines, hydraulic cylinders and hull penetrations were examined; no oil leakage, corrosion or distortion of the tabs was found.

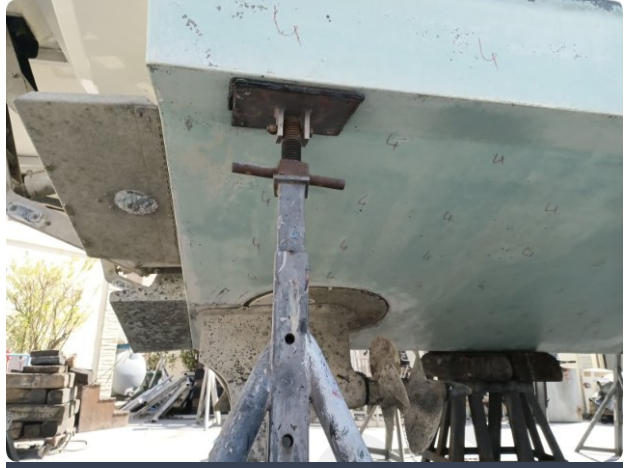
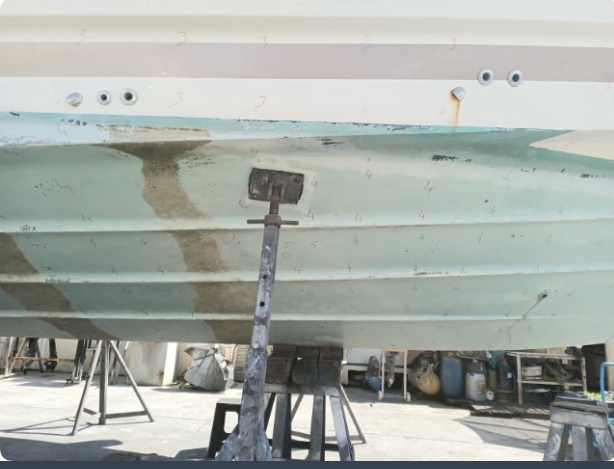
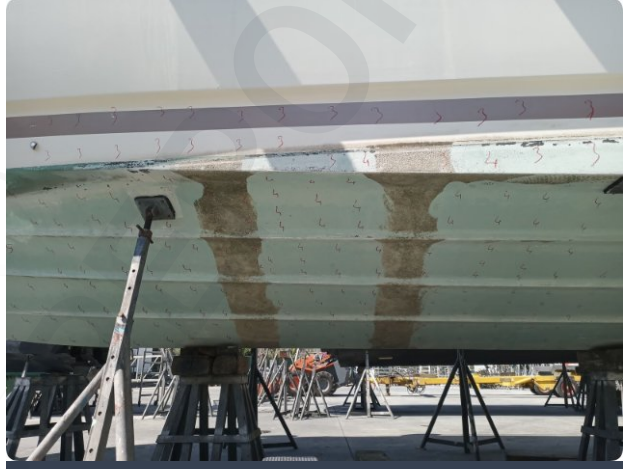
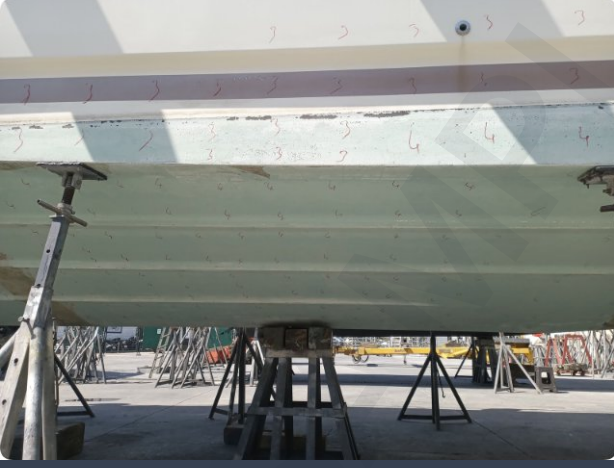
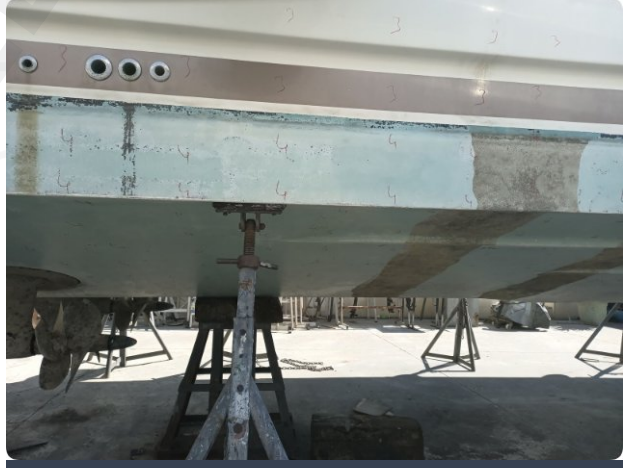
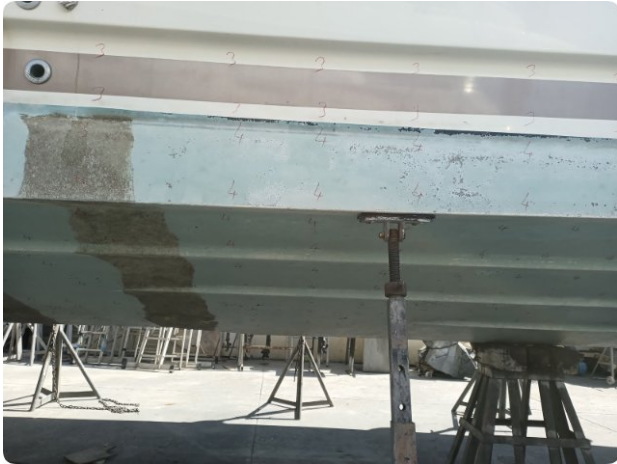
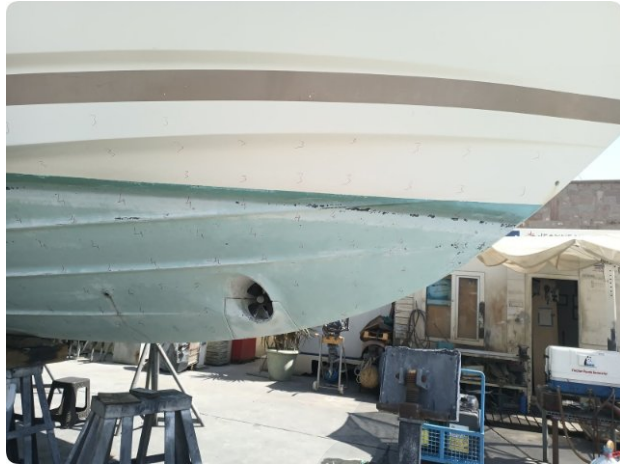
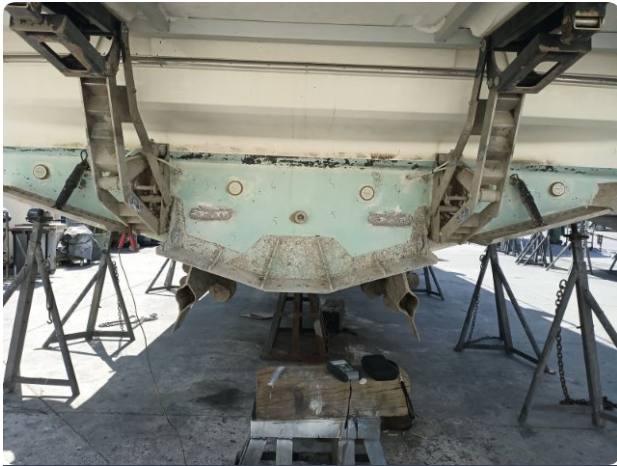
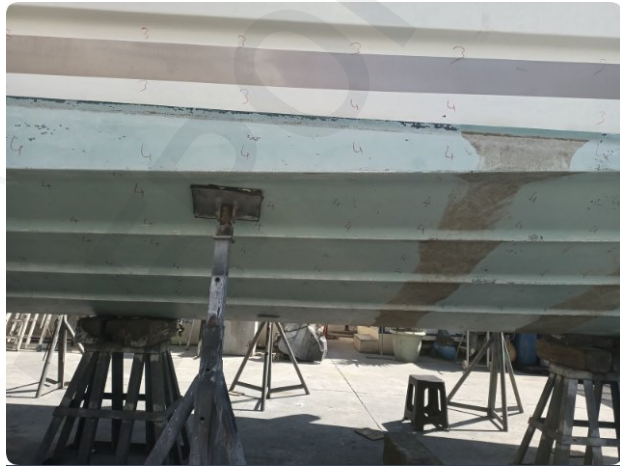
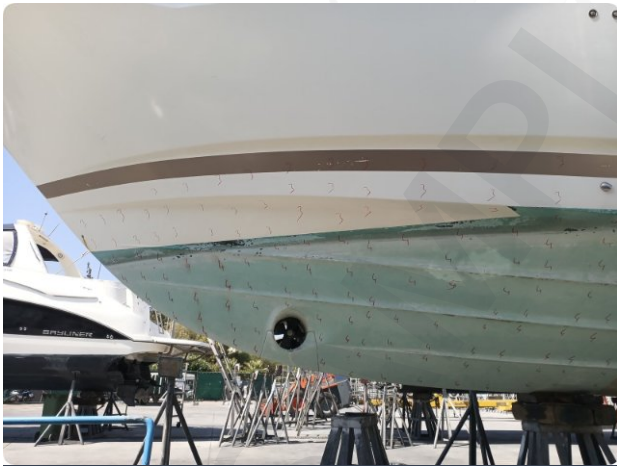
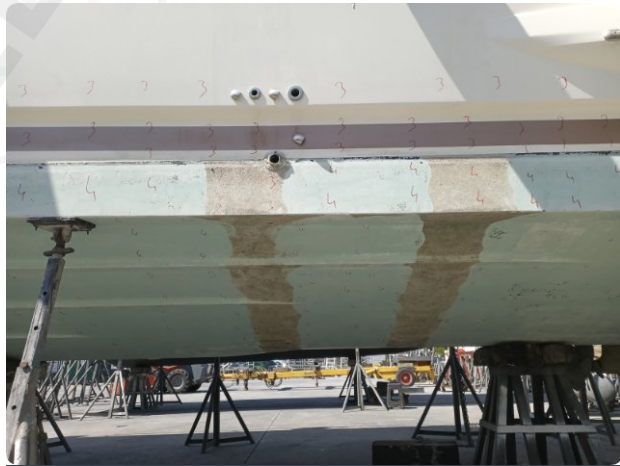
No visible osmotic blistering (moisture-related blistering beneath the gelcoat) was found on the underwater hull. The entire hull was scanned with a Tramex Skipper 5 moisture meter, percussion sounding (phenolic hammer) and a thermal camera; no findings indicative of moisture retention beneath the gelcoat, laminate saturation or incipient blistering were found. In areas where the antifouling coating had worn away or been removed, the gelcoat surface was directly visible, and no blistering or discolouration was observed in these areas either. In the surveyor's opinion, the vessel is in good condition with regard to osmosis for its age.
