MARINE SURVEY REPORT

# "SAMPLE MOTOR YACHT"

FILE NO.  
ORNEK-01-EN

Pre-Purchase Condition Survey

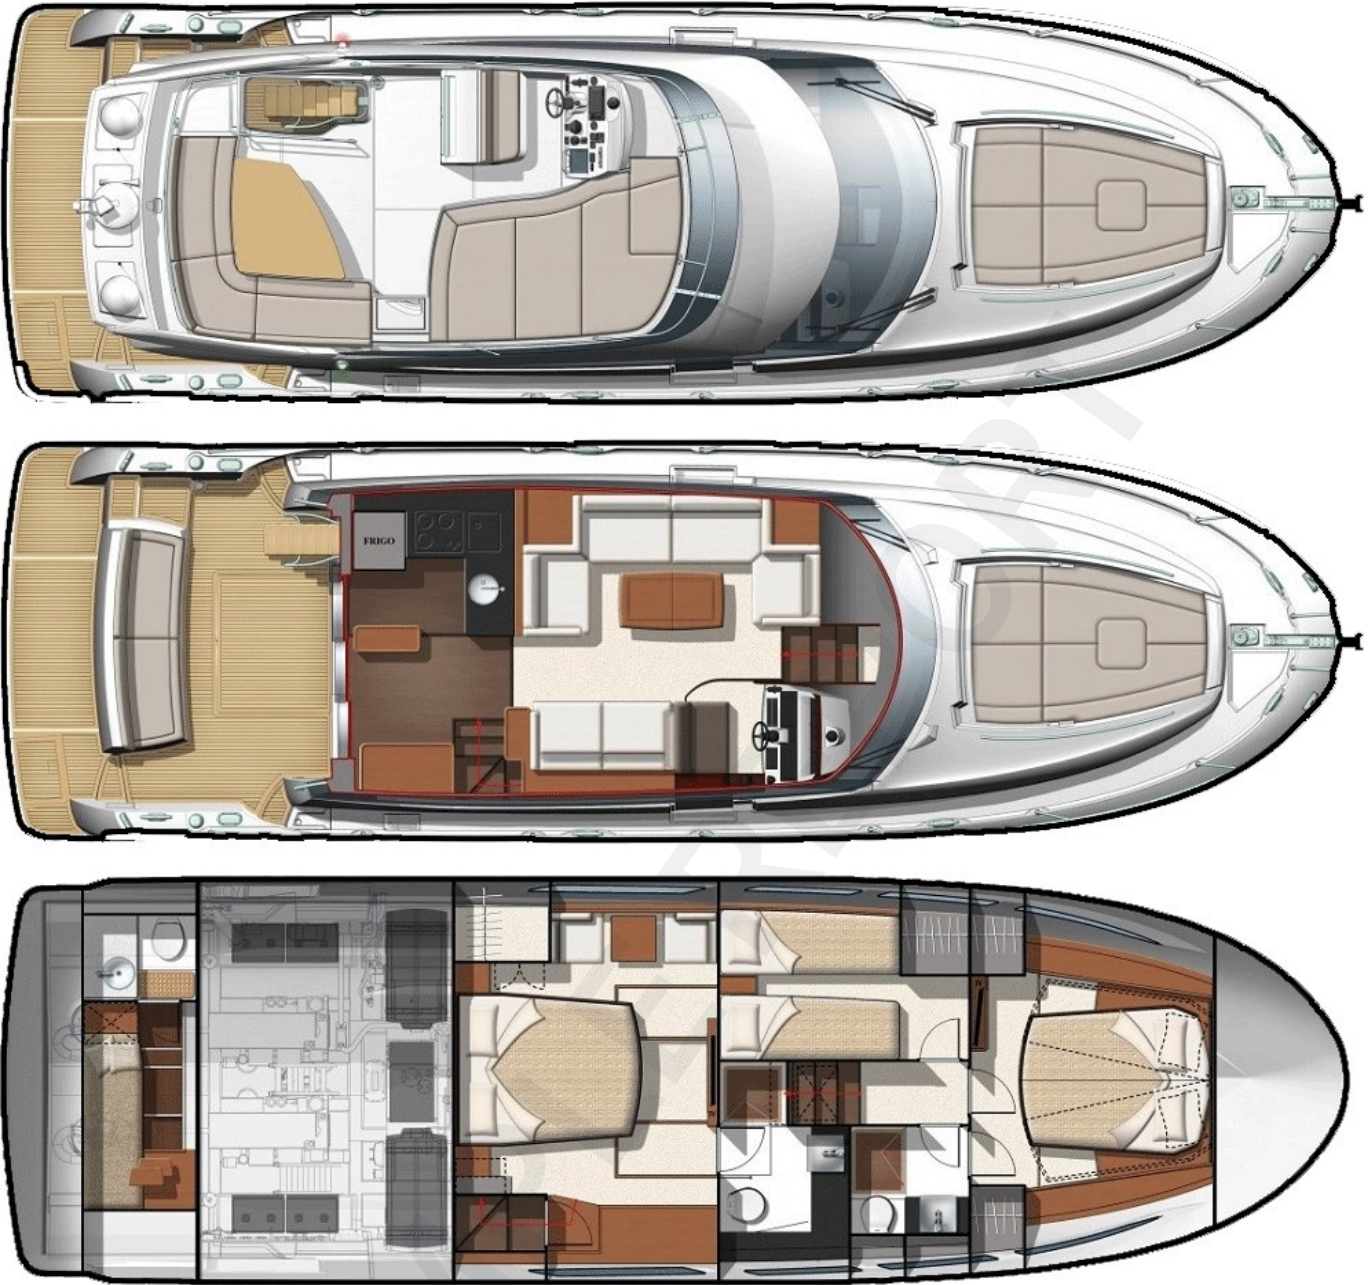
Photo 1

General arrangement plan of the vessel.

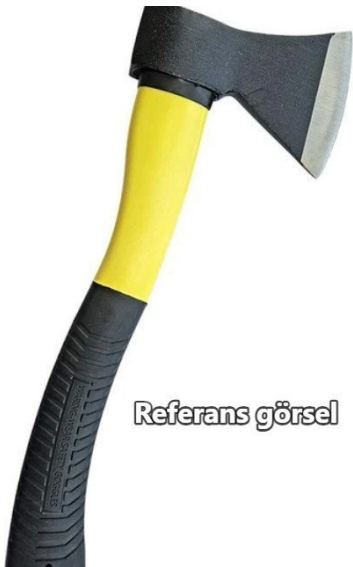
Photo 5

It was found that a fire blanket was present on board, but that a fire axe was not present.

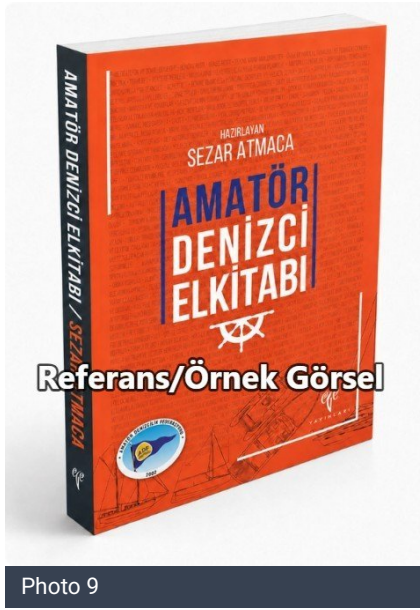
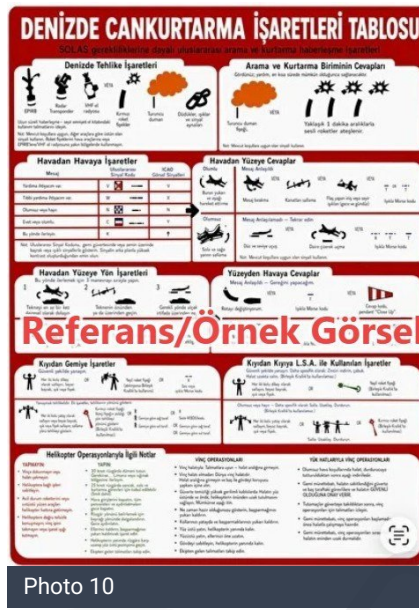
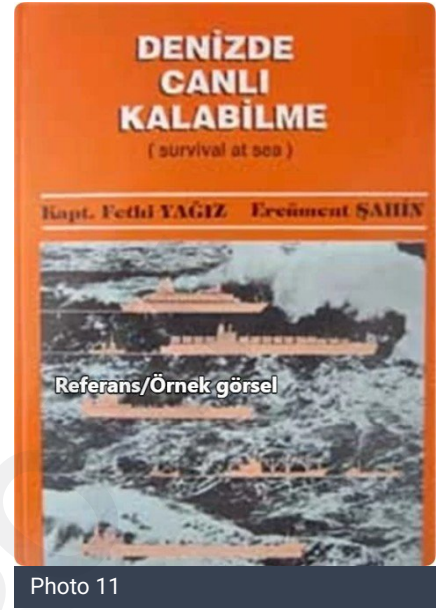
It was found that the books required to be carried on board the vessel were not present.

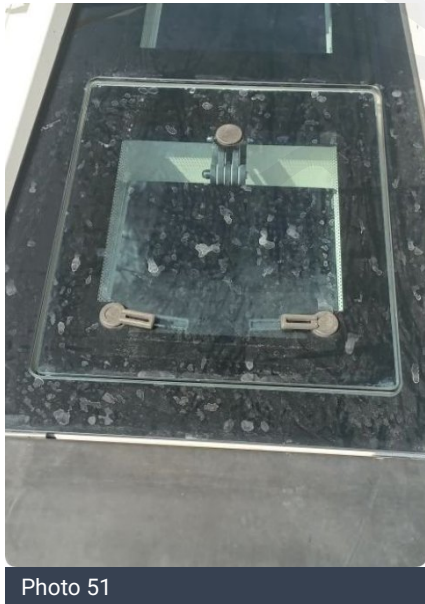
Photo 51

The cabin escape hatches are Lewmar brand; OPERATED, the locking handles were observed to move freely.

The cabin escape hatches were found to be unobstructed and operational.

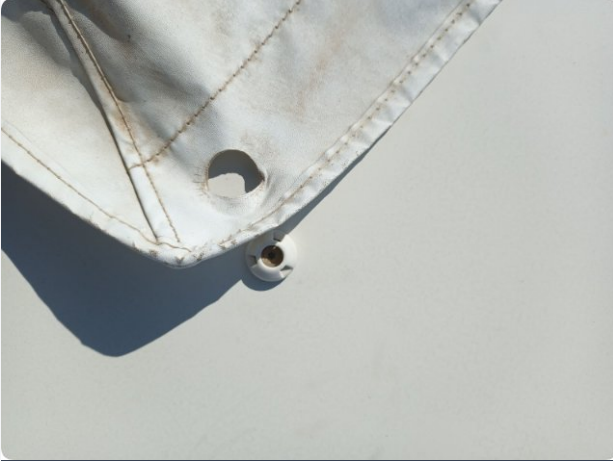
Photo 55

Some of the fastenings were observed to have broken off.

It is recommended that they be repaired or renewed.

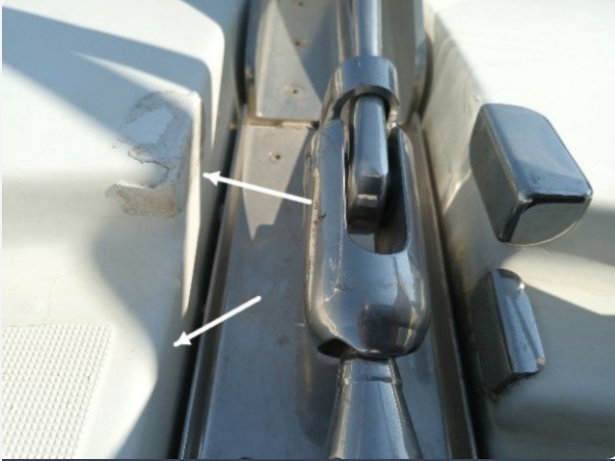
Photo 56

The port-side stainless steel guard, fitted to protect the gelcoat from the chain, was found to be missing.

It is recommended that the missing stainless steel guard be refabricated and refitted.

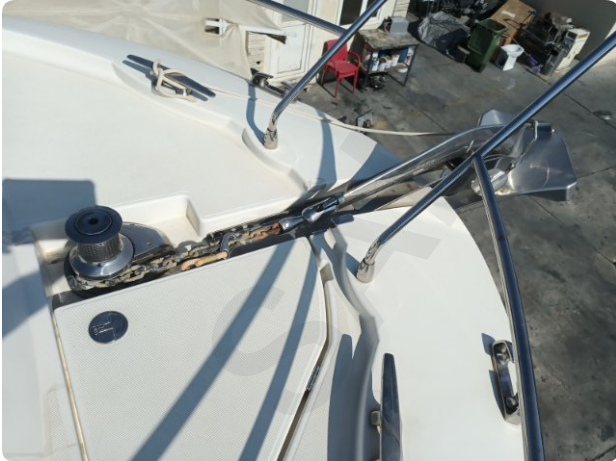
Photo 57

A 35 kg Ultra brand anchor was observed and found to be in good condition.

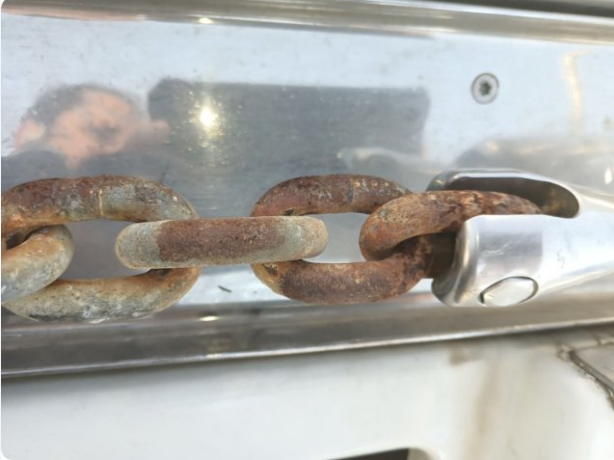
Photo 58

The chain link connected to the anchor was observed to be more worn than the others.

Three or four links at the anchor end of the chain should be removed and the chain reattached to the anchor.

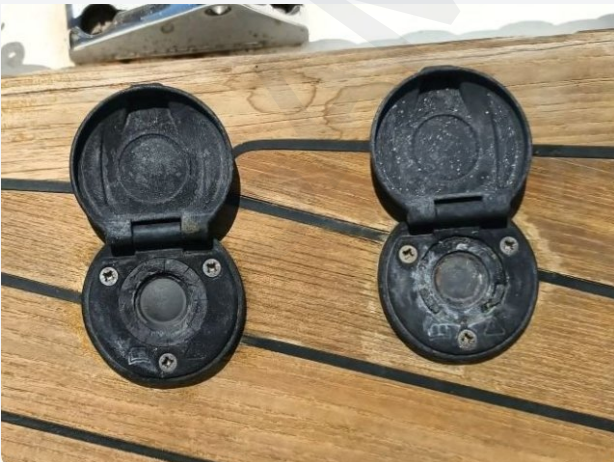
Photo 59

The deck buttons for the anchor windlass were found to be operating, but their rubber covers were found to be deformed. The deformed cover leaves the button exposed to water ingress.

It is recommended that the button covers be renewed.

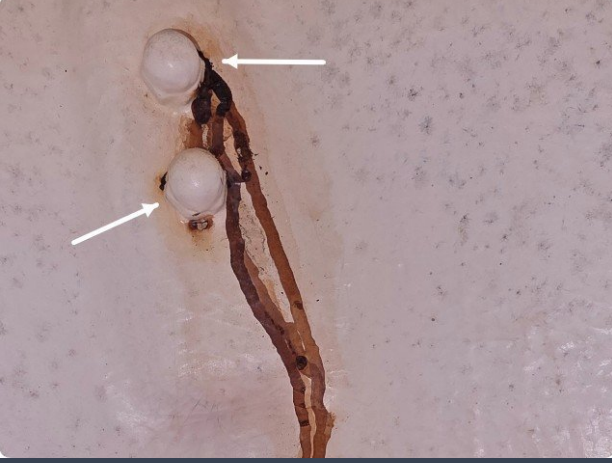
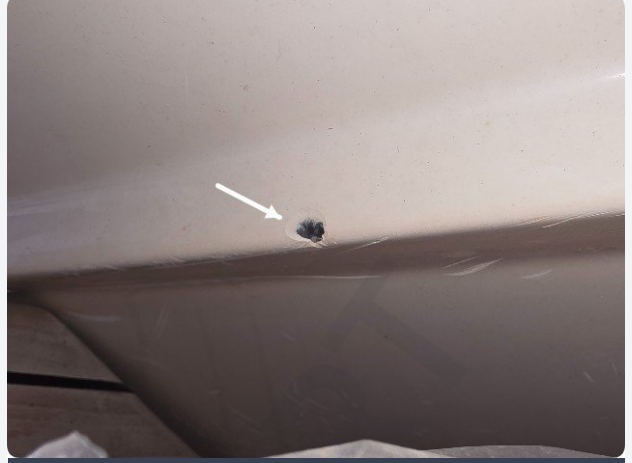
The battery health was found to be 47%.

UV-induced wear was present at the points where the oars attach to the tender.

Rust staining was present on the forward attachment bolts.

Gelcoat damage was present on the tender's underwater hull.

It is recommended that the battery be replaced should its health fall below 50%, that the UV-induced wear on the oars be remedied or the affected sections replaced, that the rust staining be cleaned and sealing ensured, and that the underwater hull gelcoat be repaired.

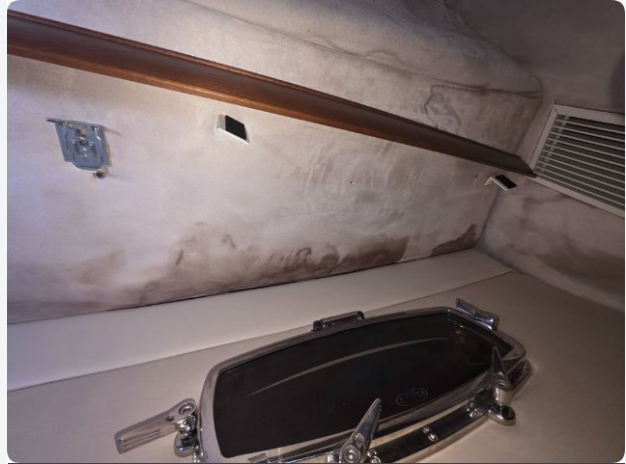
Photo 66

Staining and blistering indicative of water ingress was found on the starboard side of the master cabin headlining. In the surveyor's opinion, the leak may originate from deck fittings or from around the portlight.

It is recommended that the source of the leak be identified by means of a water test, that the deck fitting fixing bolts be removed and refitted in a watertight manner, and that the headlining be renewed once dry.

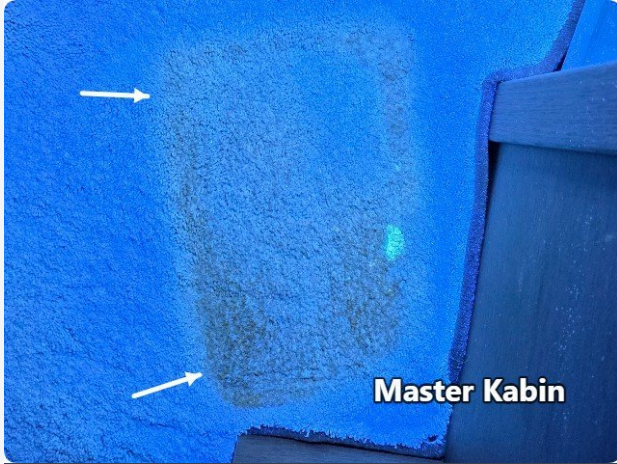
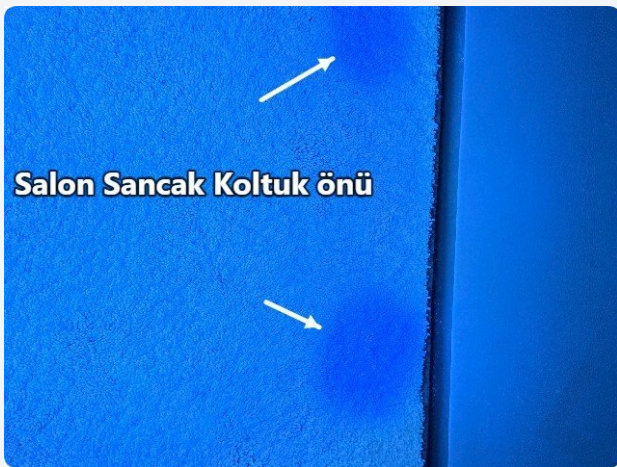
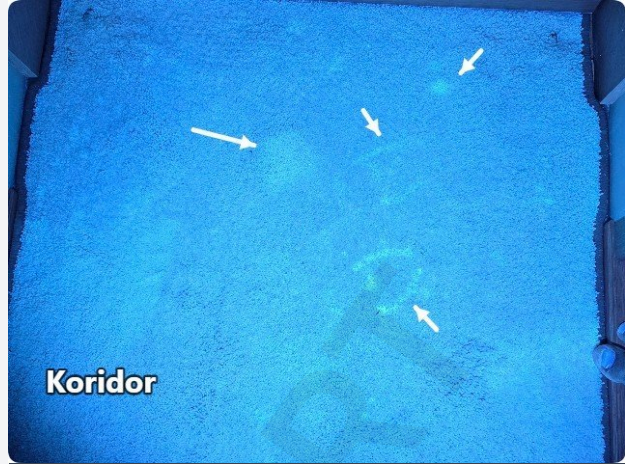
Deformed areas and stains were found in the carpet on the saloon and cabin floors.

The photographs were taken under UV light; the areas that fluoresce indicate organic stain/liquid residue.

It is recommended that this be cleaned/repared in accordance with good marine practice.

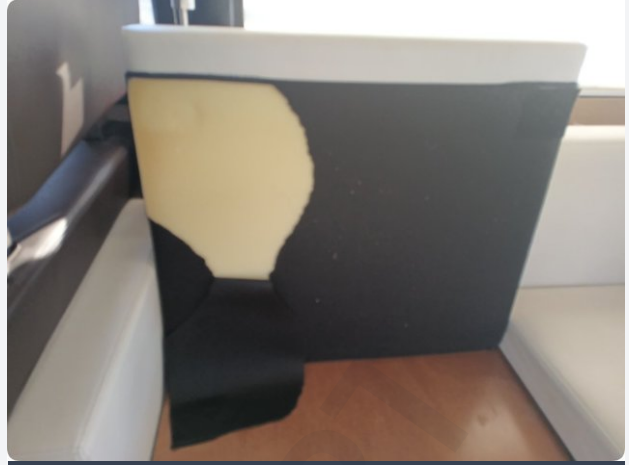
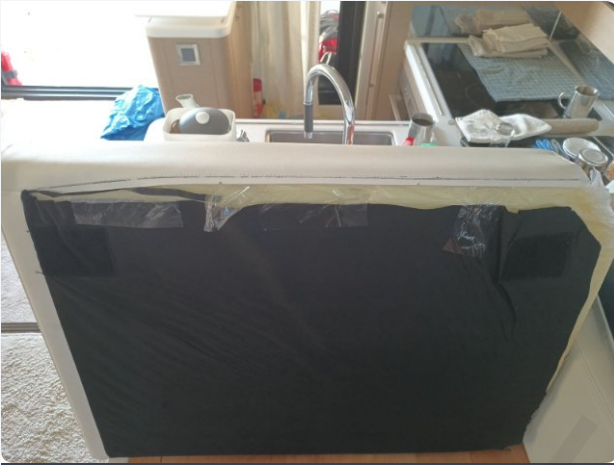
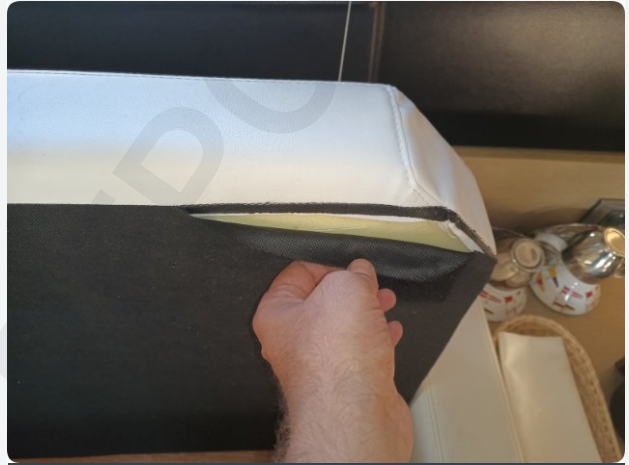
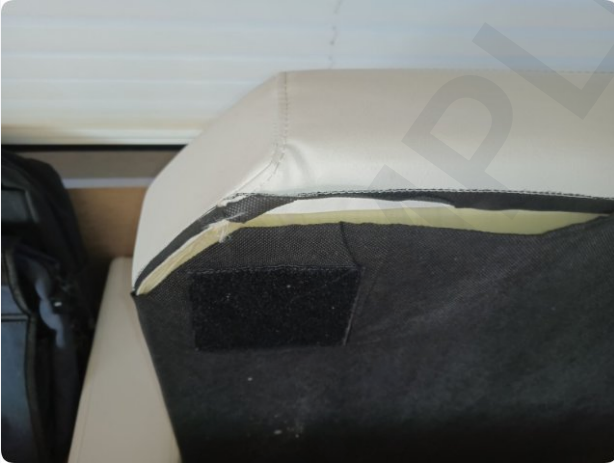
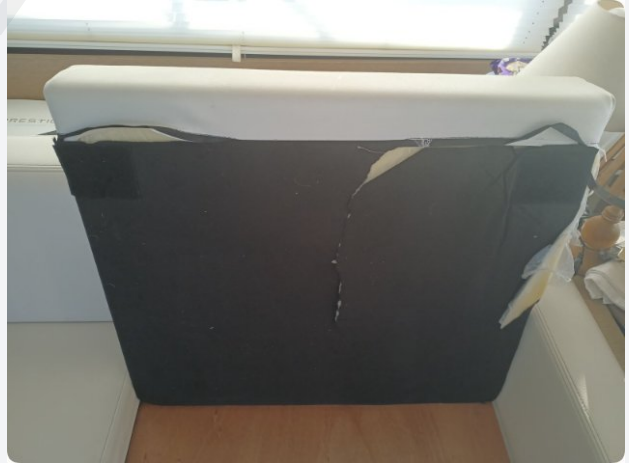
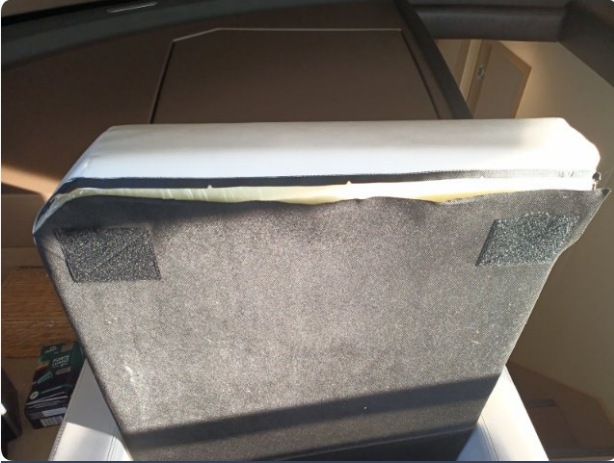
It was found that the linings beneath the seat cushion foam had worn over time and had torn in some areas.

It is recommended that these be repaired.

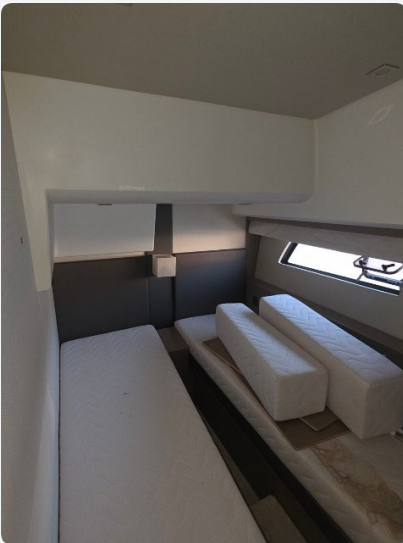
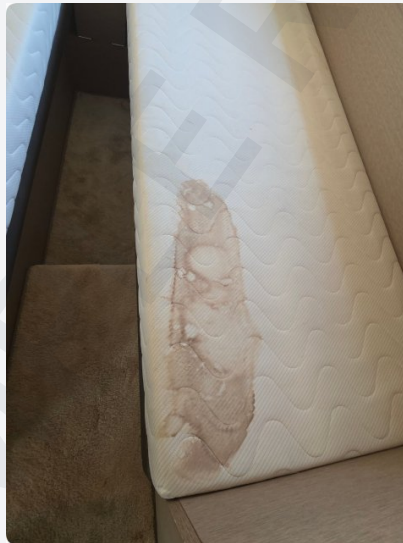
The mattresses in the port-side twin cabin were found to be dirty.

It is recommended that they be cleaned or replaced.

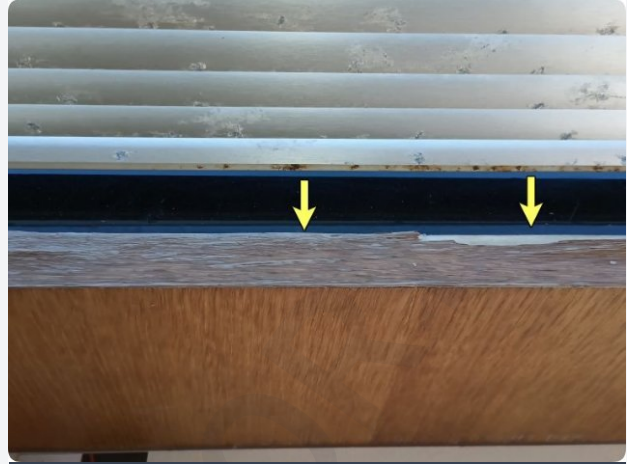
Photo 82

Blistering, considered to result from water ingress, was found on the wall linings on both the starboard and port sides of the saloon. No elevated moisture meter readings were obtained in the area where the blistering was found; the marks are considered to have occurred in the past.

It is recommended that the deck fittings and window surrounds above the areas showing blistering be checked for watertightness, and that the lining be renewed if considered appropriate.

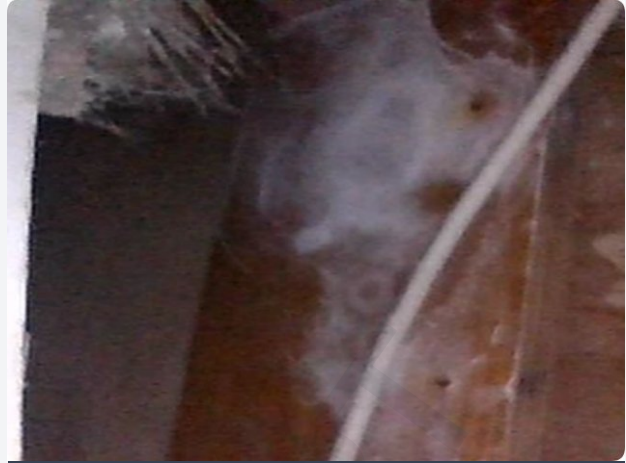
Photo 84

Traces of water were found on the headlining in the forward VIP cabin. The trace was dry; no active dripping was observed during the survey.

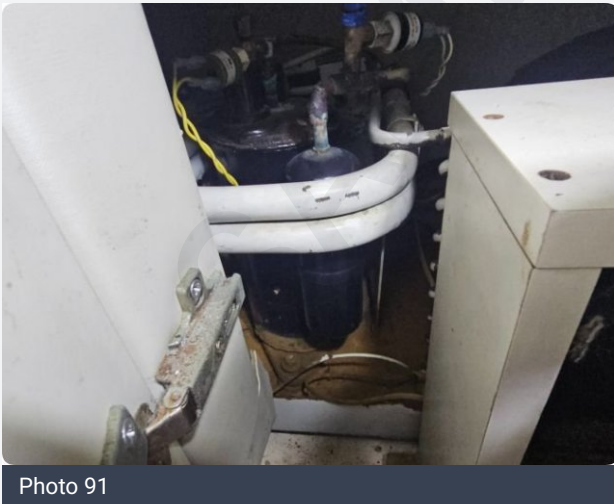
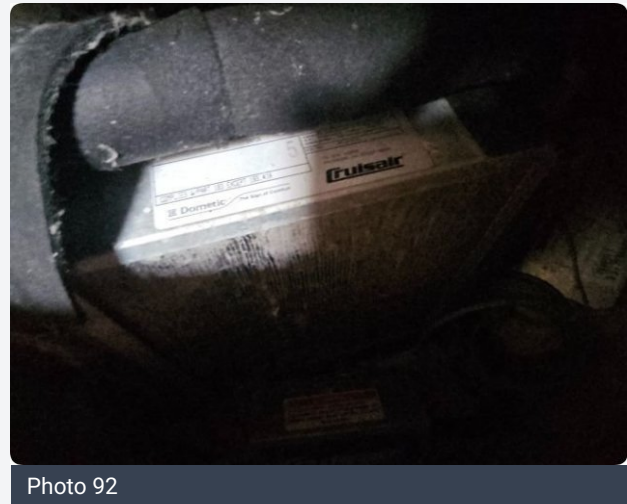
The air conditioning fan-coil units were found to be generally under-maintained, with dust and dirt build-up on the fins. The units were operating, but the dirty fins are reducing efficiency.

It is recommended that the fan-coil units and filters be cleaned, and that the condensate trays and drain lines be checked.

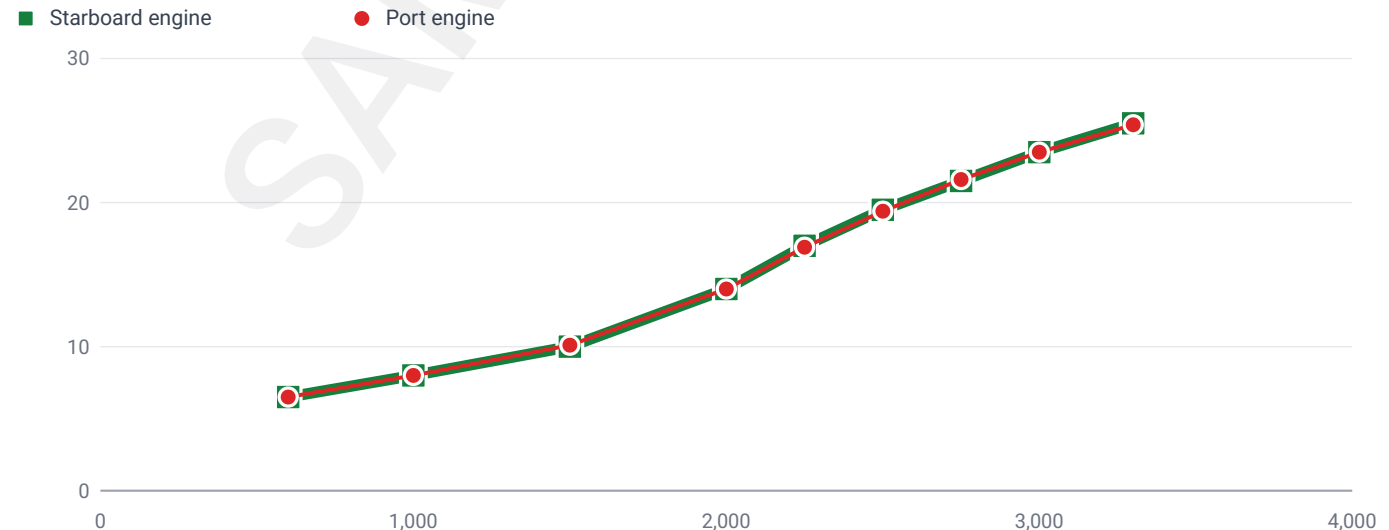
## Speed vs RPM kn · rpm

The rated speed of the port engine is 3,500 rpm. The highest speed reached in this run was 3,300 rpm, which corresponds to 94.3% of the rated speed (-200 rpm).

At each stage, both engines were operated together, with RPM read from one engine on each measurement round. At full throttle, 3,300 rpm was reached on both engines; this value is 94.3% of the full-throttle RPM stated on the engine data plate (3,500 rpm), representing a shortfall of approximately 200 rpm. The fact that the shortfall is similar on both engines points to a common cause on the propeller or hull side rather than a fault specific to a single engine; the hull surface and propeller blades should be investigated first.

The cause of the RPM loss should be investigated: the underwater hull and propeller cleanliness, propeller pitch, fuel filters and air intake path should be checked in turn; if no resolution is achieved, the engines should be subjected to a load test at an authorised service centre. The RPM loss causes the engines to be continuously overloaded at full throttle.

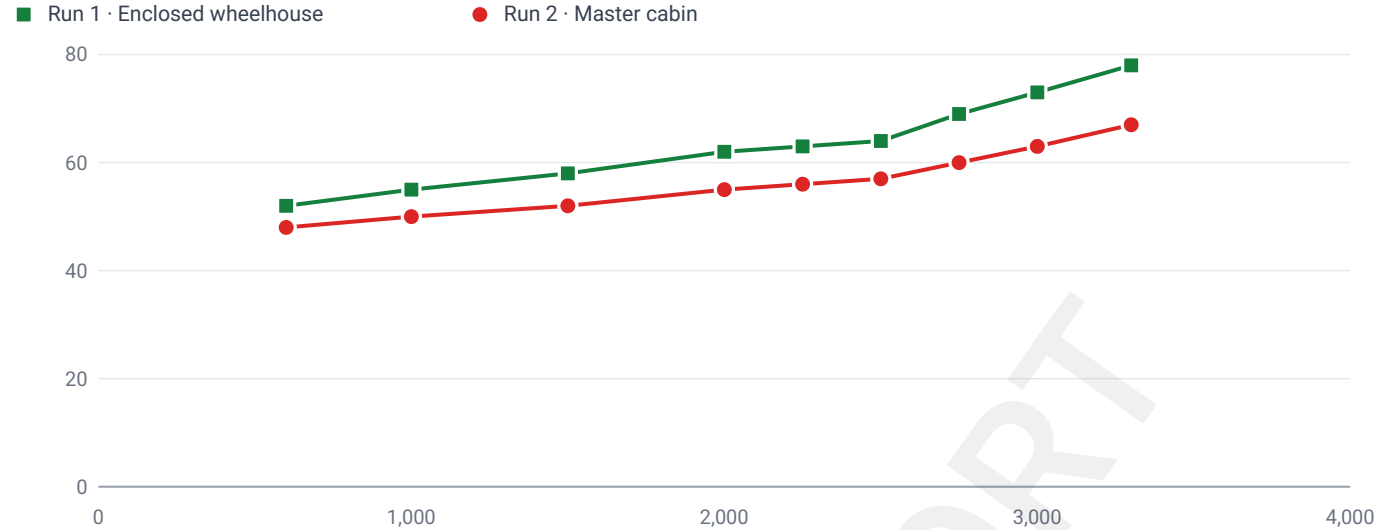
**Sound level vs RPM dBA · rpm**

Sound level was measured in the enclosed wheelhouse using a digital sound level meter at two operating stages. It was found to be 78 dBA at full throttle and 64 dBA at cruising speed. The measurement was taken with doors and windows closed and the air conditioning off; in the surveyor's opinion, the values are within the normal range for a motor yacht of this class.

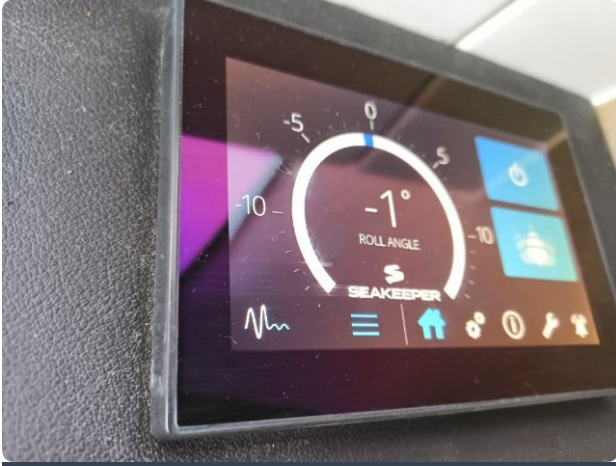
Photo 114

A Seakeeper gyroscopic stabiliser is fitted; it was stated to have been installed in 2024 (AS REPORTED BY THE CAPTAIN). OPERATED; during the sea trial the vessel was put beam-on to the waves and the stabiliser was observed to reduce rolling significantly.

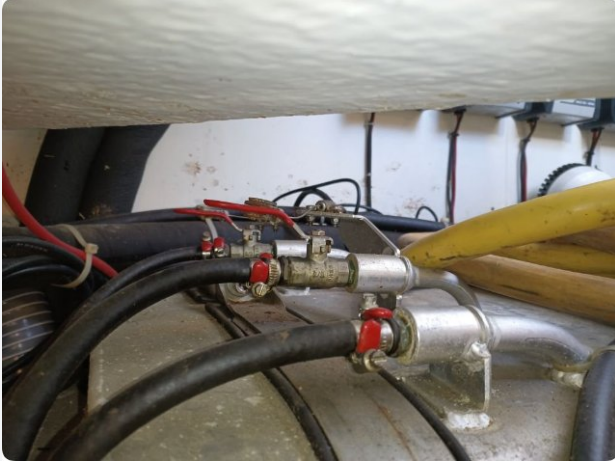
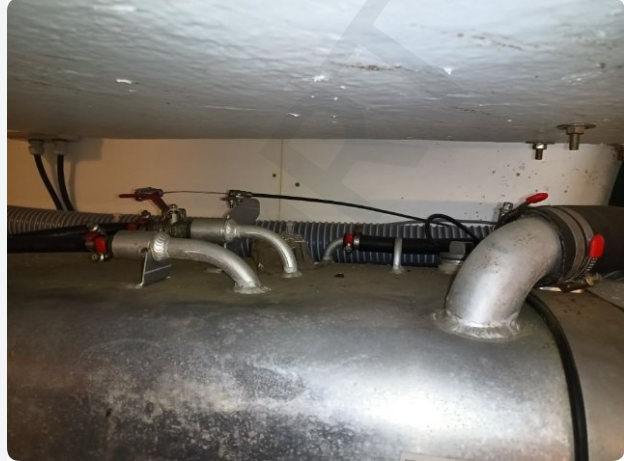
It was found that the fuel tank fill connections were not bonded WHERE SIGHTED. The fill fitting, pipework and tank should be connected to a common bonding conductor in order to dissipate static electricity generated during filling.

It is recommended that bonding continuity from the fill fitting to the tank be established and verified by measurement (practice falling under ABYC H-33). Additional care should be taken during fuelling until bonding has been completed.

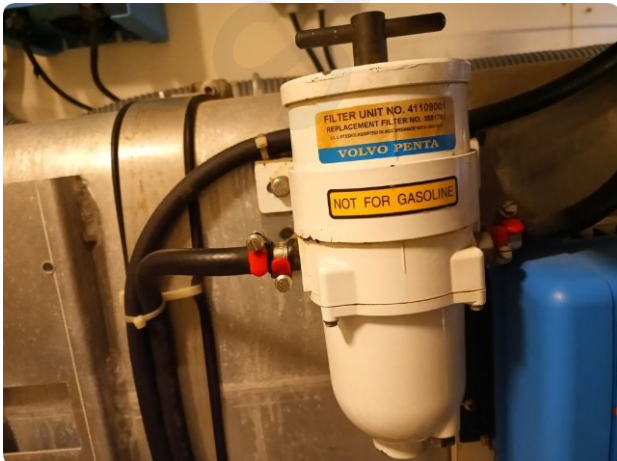
Photo 119

Each engine has its own genuine primary fuel filter (with water separator) and an engine-mounted secondary filter. The sight glasses of the water separator bowls were checked, and the filter bodies and connections were inspected for signs of leakage. The engines' fault memory contains a stored code indicating water present in the fuel pre-filter (see Diagnostic Comments).

It was observed that a warning indicating the presence of water in the primary fuel filter (SPN 97 FMI 3) had been logged twice in the starboard main engine's fault memory. The warning was not active during the survey; no water was observed in the water separator bowl on the day of the survey.

A bottom sample should be taken from the fuel tank to check for water and sediment, the water separator bowl should be drained, and the filter elements should be renewed. Should the warning recur, the tank vent and the deck fill gasket should be checked. (Water in the fuel can damage the injection equipment and cause loss of power while underway.)

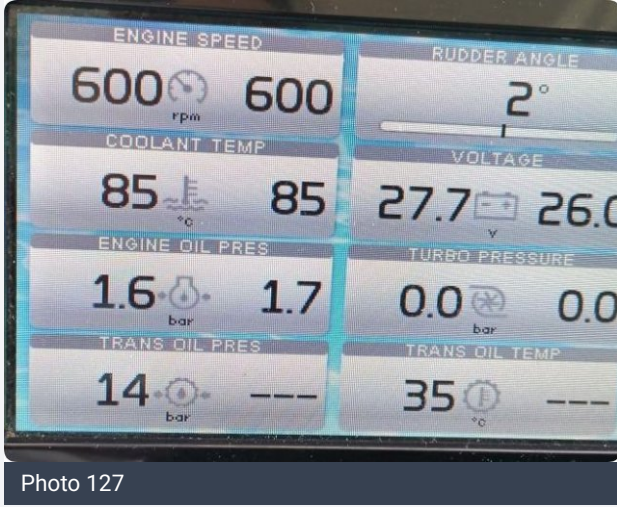
Photo 127

Four records of supply voltage dropping below the lower limit during cranking (SPN 168 FMI 1) were found in the fault memory of the port main engine. Supply voltages read from the EVC display during the sea trial differ between the two engines (27.7 V / 26.0 V).

It is recommended that the starter battery bank be measured under load; that the tightness, cross-section and connection resistance of the battery terminals and starter cables be checked; and that any batteries with a health value below 50% be replaced (see service batteries finding).

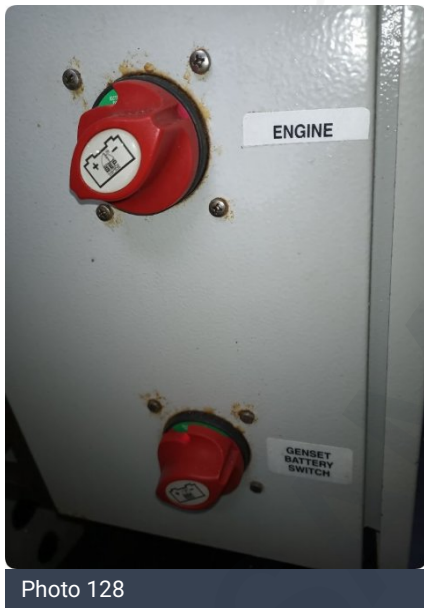
Photo 128

The main engine and generator battery isolator switches (Blue Sea Systems) are located in the engine room, labelled. OPERATED; the switches were observed to be SERVICEABLE.

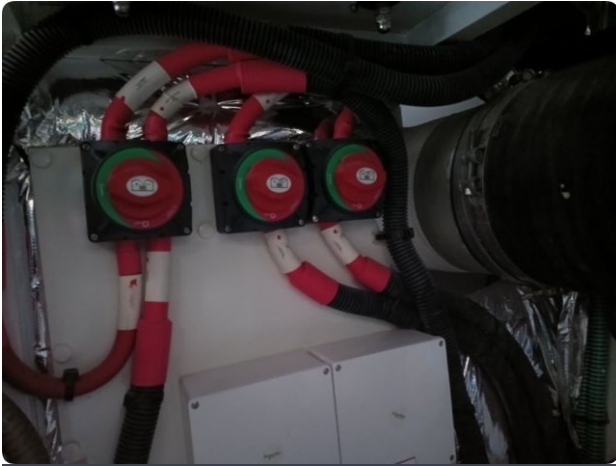
Photo 129

The main DC breakers are located on the distribution panel in the engine room; they were operated and observed to break the circuit.

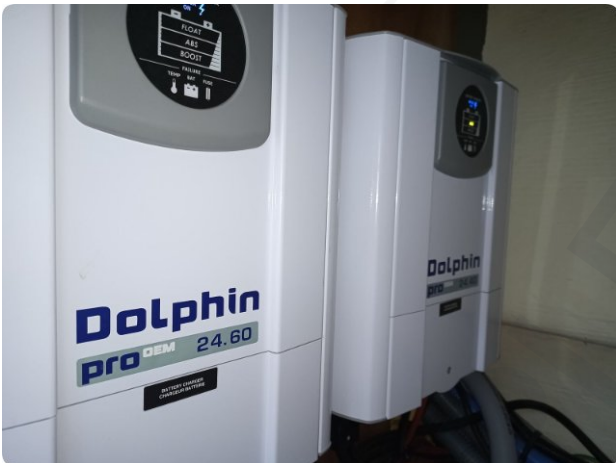
Photo 130

There are 2 chargers of the Dolphin Pro Dem 24.60 and 24.40 models. They were observed to be SERVICEABLE.

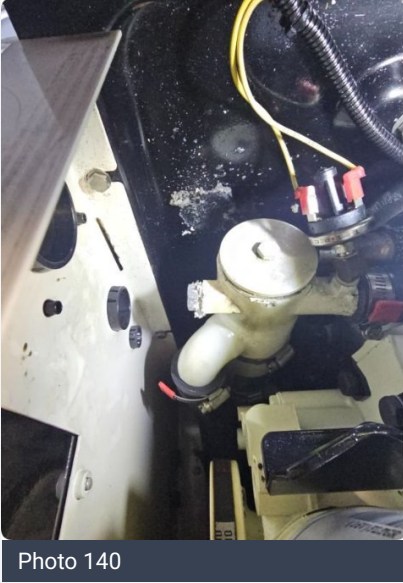
As stated by the attending marine technicians, the condenser is blocked, causing the hoses to swell and preventing the system from operating properly.

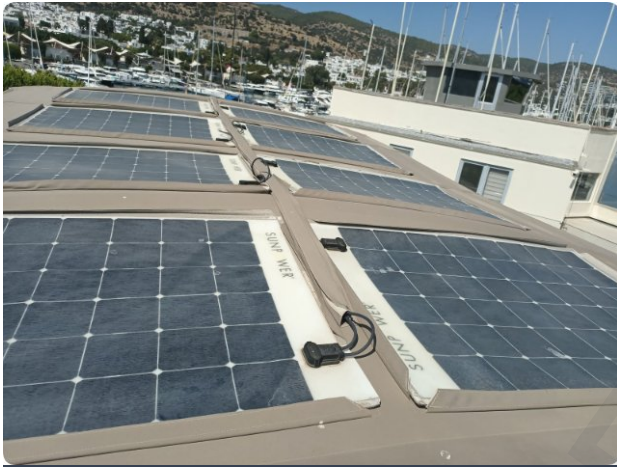
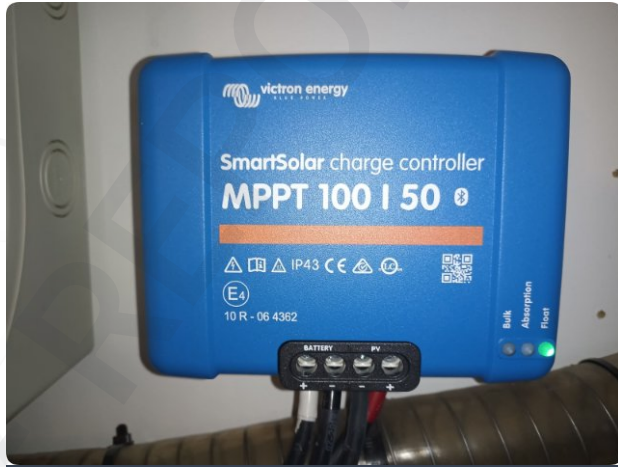
Solar panels, fitted subsequently on the flybridge, supply the battery bank via a Victron charge regulator. The regulator display showed that the panels were supplying current.

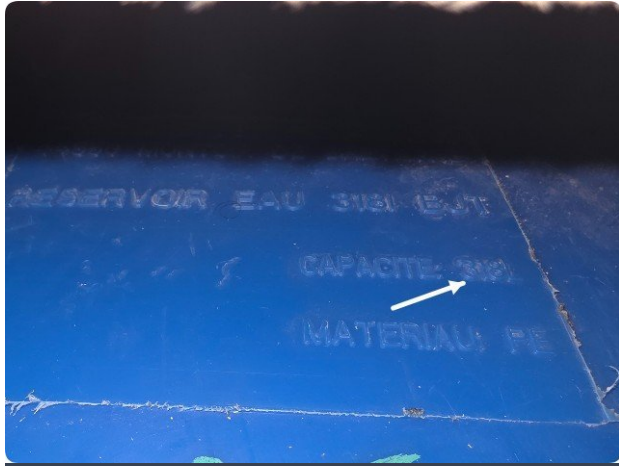
Photo 157

There are 2 water tanks of 318 litres each (636 litres total).

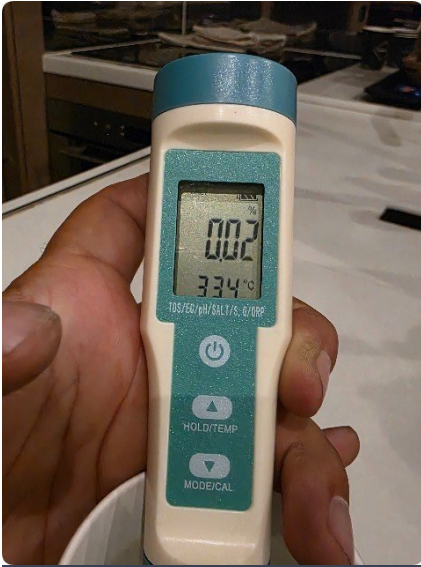
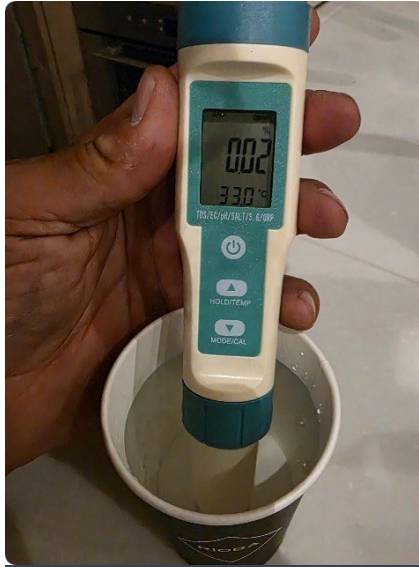
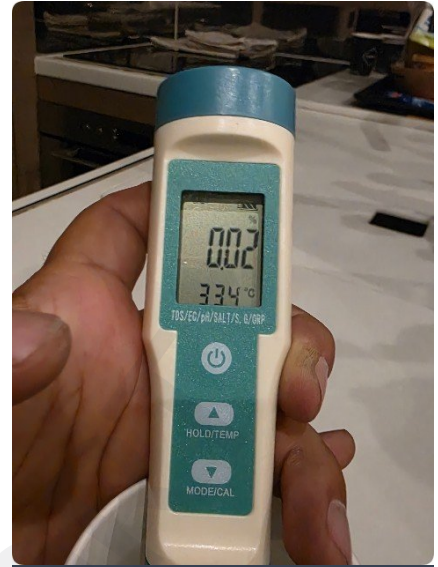
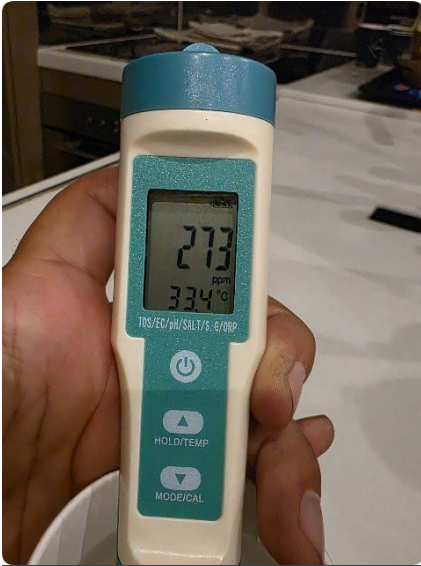
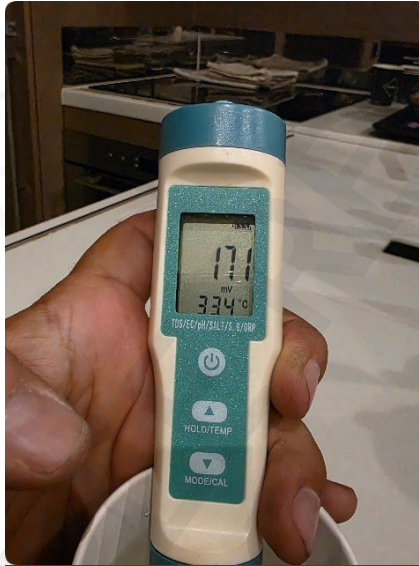
Analysis: In the surveyor's opinion, this is a notably high temperature value for fresh water.

Rationale: In the surveyor's opinion, the combination of the low ORP value (171 mV) with a temperature above 30°C creates optimum incubation conditions for the rapid growth of biological activity (particularly Legionella and other bacterial contamination) within the tank and plumbing.

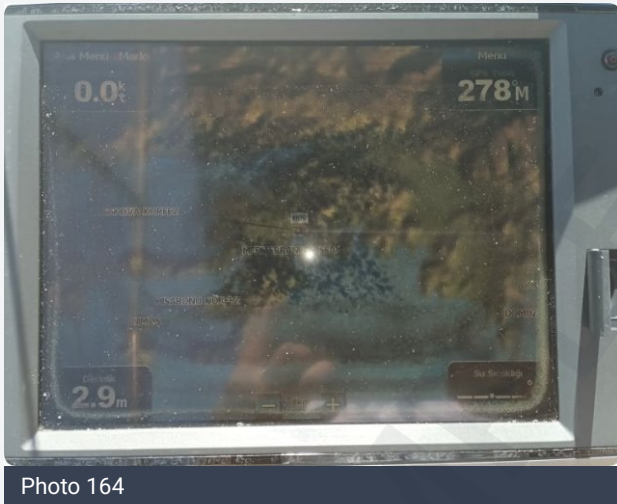
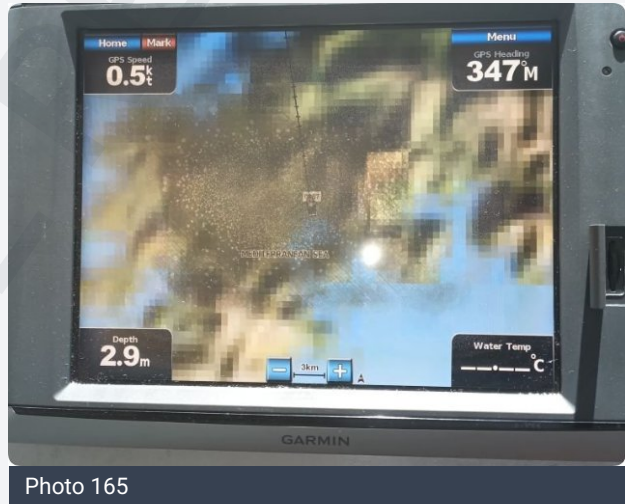
It was found that navigation charts were not loaded on the multifunction navigation displays; no chart card was present in the flybridge display. The other functions of the displays are operational.

It is recommended that up-to-date electronic charts for the region be obtained and loaded onto both displays, and that it be confirmed with the seller whether the chart card will be provided together with the sale of the vessel.

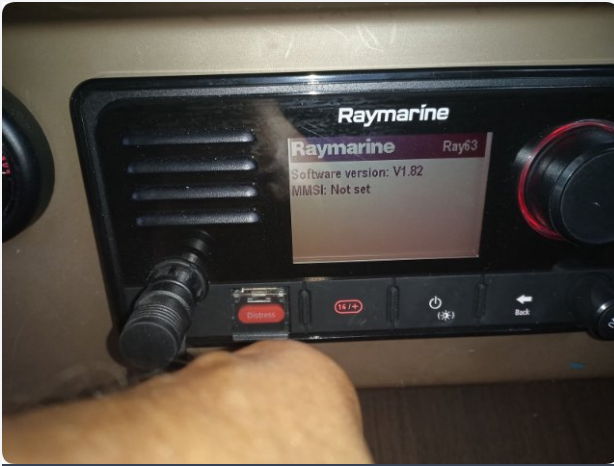
Photo 166

It was found that the MMSI number had not been programmed into the unit.

It is recommended that it be programmed into the unit.

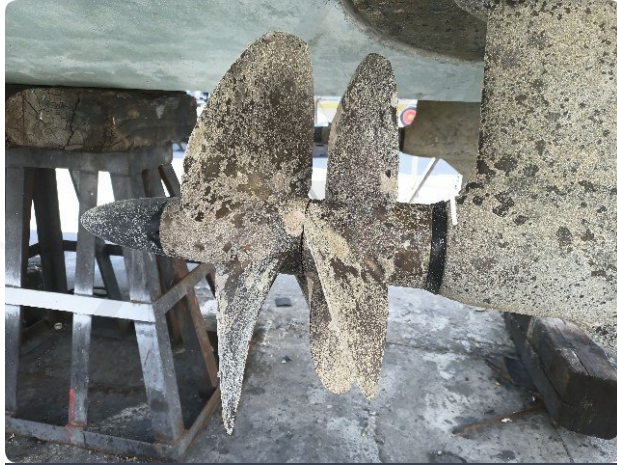
Photo 168

The specialist propeller coating (Seajet) applied to the propellers was found to have flaked and separated from the surface in some areas. No bending, cracking or cavitation erosion was observed on the blades.

It is recommended that the areas where the coating has flaked be cleaned and the coating reapplied, and that the blade surfaces also be checked separately during the process.

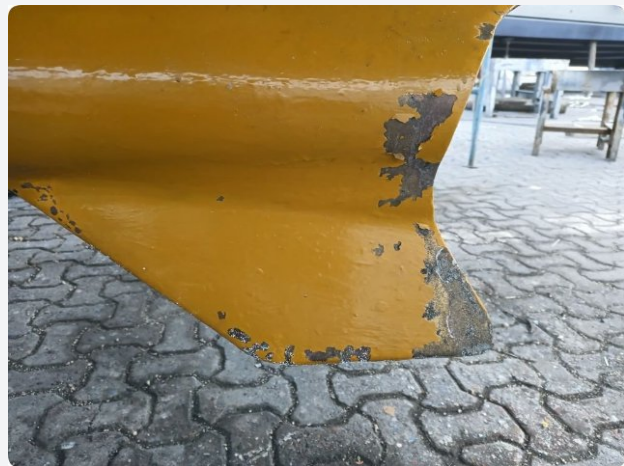
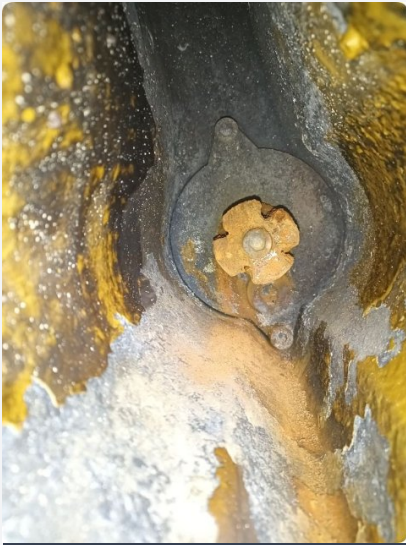
Corrosion was found in the tail (shaft) area of the starboard pod unit. The corrosion is concentrated on the shaft surface and in the area where the shaft meets the pod housing.

It is recommended that the corroded surface be cleaned and coated with a suitable protective product, and that the shaft seal and the pod's hull penetration be inspected at an authorised service centre.

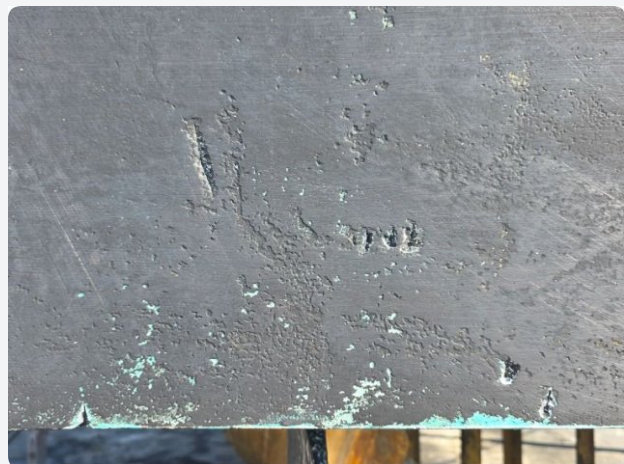
**Finding B-47**

Deformation was found in the gelcoat at the aft section and midship area of the underwater hull. In addition, wear was found in the epoxy barrier coat (Gelshield). (SAMPLE REPORT NOTE: This finding does not relate to this vessel; it has been taken from another survey and included here to illustrate how a finding is written up in the report.)

**Recommendation**

It is recommended that it be monitored and, if necessary, repaired in accordance with good marine practice.

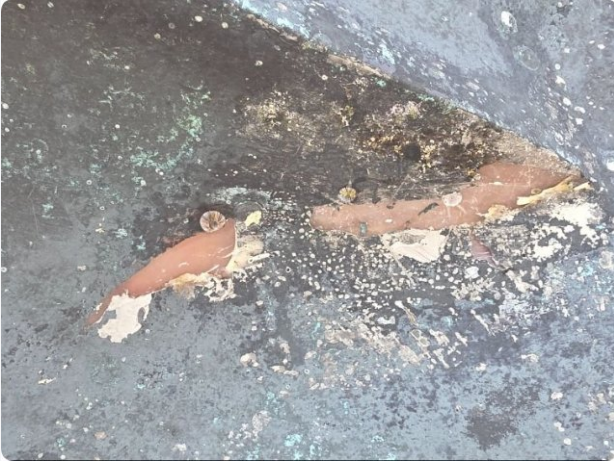
Photo 222

#### Finding A-10

Delamination was found at the locations shown in the photographs. The identified locations were examined internally with an endoscope, and deformation was observed in the fibre. (SAMPLE REPORT NOTE: This finding does not relate to this vessel; it has been taken from another survey and included here to illustrate how a finding is written up in the report.)

#### Recommendation

It is recommended that further investigation be carried out and, if necessary, that it be repaired in accordance with good marine practice.

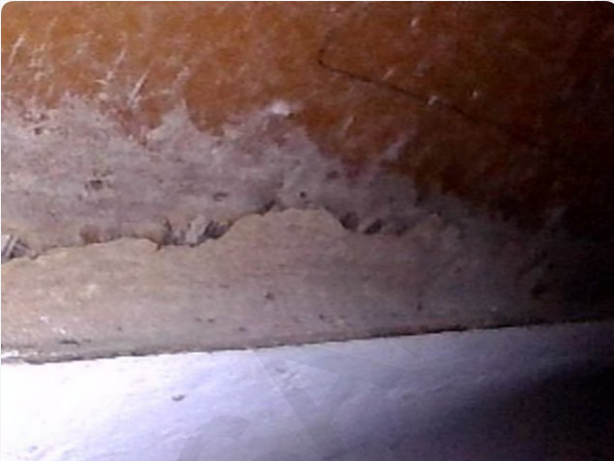
Photo 223

#### Finding A-11

At the starboard bow shoulder, where paint and gelcoat repair had been observed during the night-time infrared inspection, percussion sounding (phenolic hammer) returned a dull sound. The area was examined internally with an endoscope camera through the access hatch beneath the deck; delamination of the laminate layers and resin separation were found. The delamination lies beneath the cosmetic repair carried out from the outside and cannot be seen from the surface.

**Recommendation**

It is recommended that the extent of the delamination be determined by opening up the area at a shipyard, that the laminate be repaired in accordance with good marine practice, and that the vessel not be operated under load (at full throttle and in a seaway) until the repair is completed. (It is suggested that past damage, repair and insurance records be requested from the seller.)

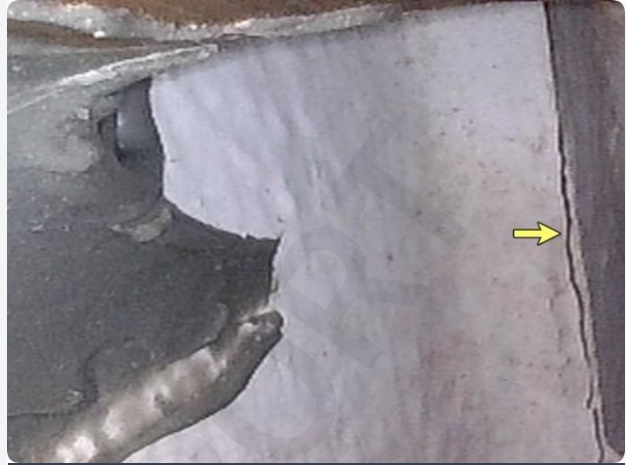
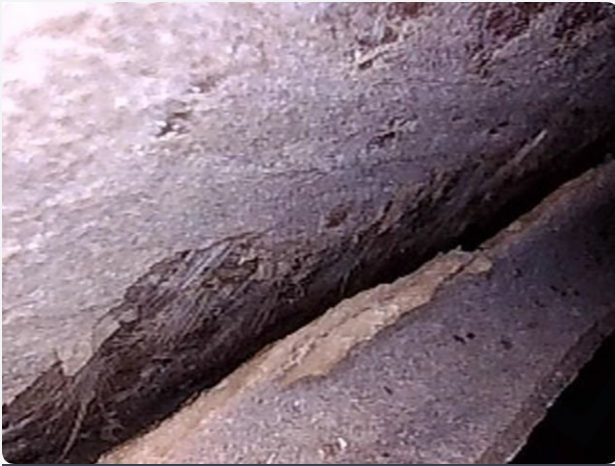
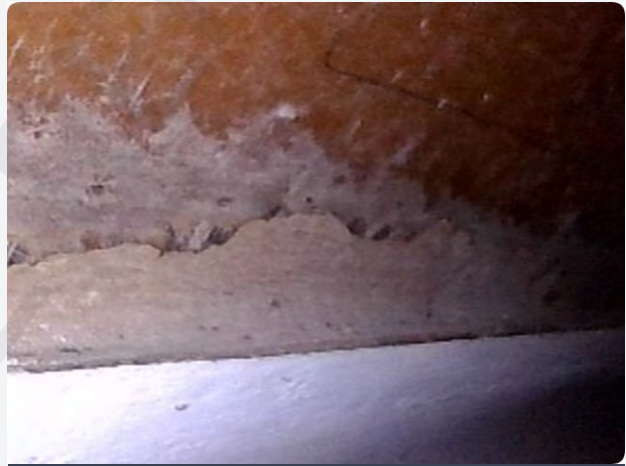
**Finding A-12**

At the bow section of the underwater hull, four cracks in total were found extending downward from beneath the bow thruster tunnel, two each on the port and starboard sides. When the area around and over the cracks was scraped open, it was observed that the cracks did not remain confined to the gelcoat surface but extended down to the laminate. When the area was checked with a phenolic hammer, a different sound was returned compared with the surrounding area, and the moisture meter readings also showed higher readings than the adjacent areas.

**Recommendation**

It is recommended that the cracked areas be opened up at a shipyard and repaired through the full laminate thickness, that the area also be inspected from the inside prior to repair, and that the junction between the bow thruster tunnel and the hull be separately examined. The vessel should not be taken to sea before the repair is completed.
